Title	LIFEPAK 35 Technical Bulletin				Page	Page 1 of 30
QS Process	Field Service, Depot, Aftermarket	Owner	DAVID.HUBER		Doc #	M0000021809
Doc State	Release	Effective Date	07 Jul 2025		Doc Rev	AD
QS Parent	7000180, Servicing Process Work Instruction					
Confidential – Stryker Proprietary Information – Do Not Duplicate

Technical Bulletin

Bulletin Name: TB_LP35_Tech Bulletin

Product Family: LIFEPAK 35

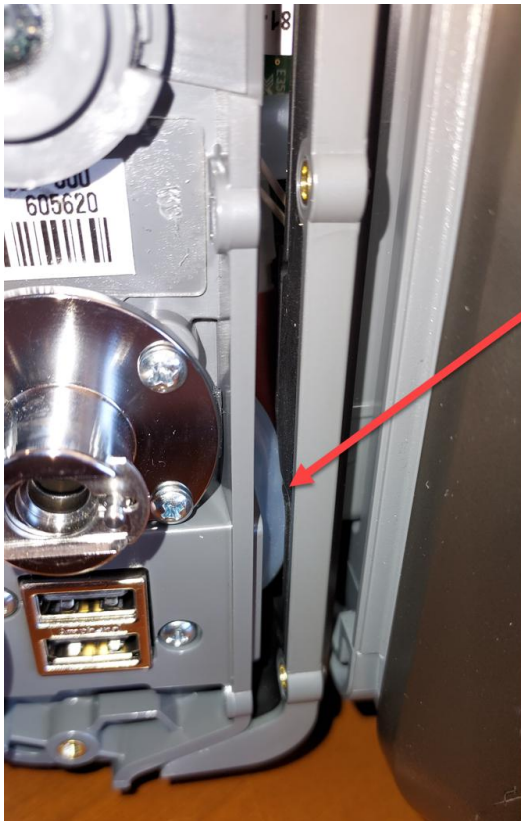
4.2.2. Neonate Alarm

The LP35 has a neonate alarm that alerts when the device senses that the cuff is inflating too quickly. This can be triggered if the cuff is put on the patient too tightly. There should be space to fit two fingers between the cuff and patient.

The Neonate Alarm can also occur if the NIBP internal hose is partially kinked because of a repair. When installing the PMOD, take care not to pinch the NIBP hose.

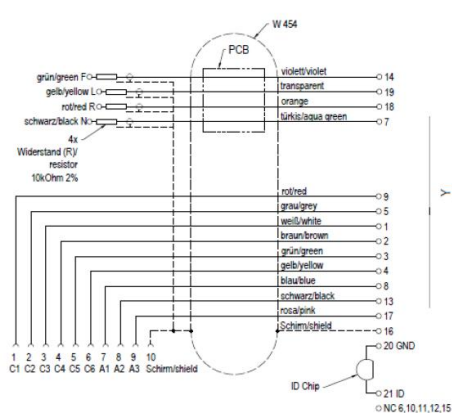
4.3.5.ECG Leads Off and Noise

- For most ECG troubleshooting, remind customers to check their cable connection, not just leads.
 - Can be hard to see with the cable tucked in the bag and behind it's shield so do a physical check.
- ECG Leads Off can be triggered by a partially disconnected cable.
- Multiple leads are on the lower half of the cable.
 - If you lose RL, you get leads off and ----.
 - If you lose more than 2, you get leads off.
- Troubleshooting in manual is incomplete and does not include a check cable connection.
 - Restarting device will clear alarms until connection is reestablished.

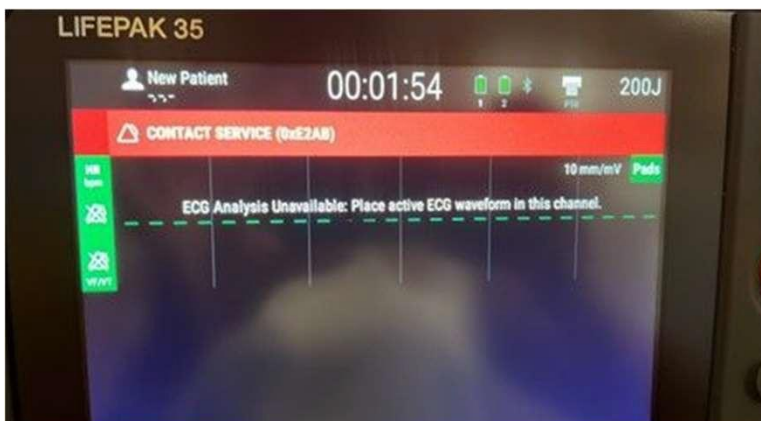
4.6. E2AB Error

- Code has been seen during charging in training scenarios primarily.
- Can happen if they are pressing the buttons too quickly, like pressing charge and quickly pressing the energy select. Device sees energy mismatch.
- Should clear itself when they deliver shock.
- If seen in this scenario, no additional service is required.
- If seen in other scenarios, troubleshoot.

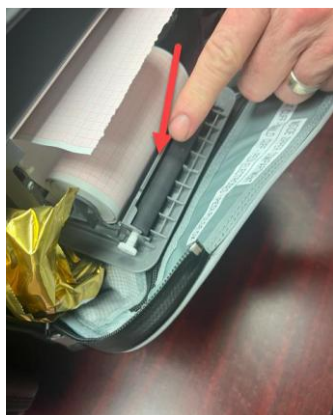
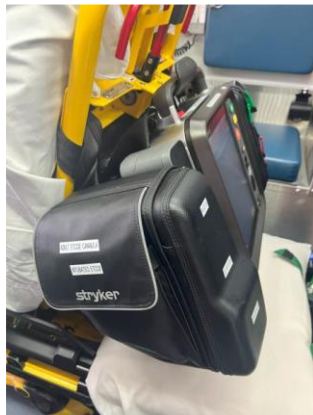
4.10. Printer Paper Jam or Shredded Paper

- Some customers are reporting paper feeding back into itself.
 - Ask customer specific questions about print issues. Do not assume it's a bad printer.
 - Customers can pull about 2 inches of paper out after tearing to avoid jamming.
- Some customers carry their devices on the back of the cot. This puts pressure on the printer, and it will feed back into itself.

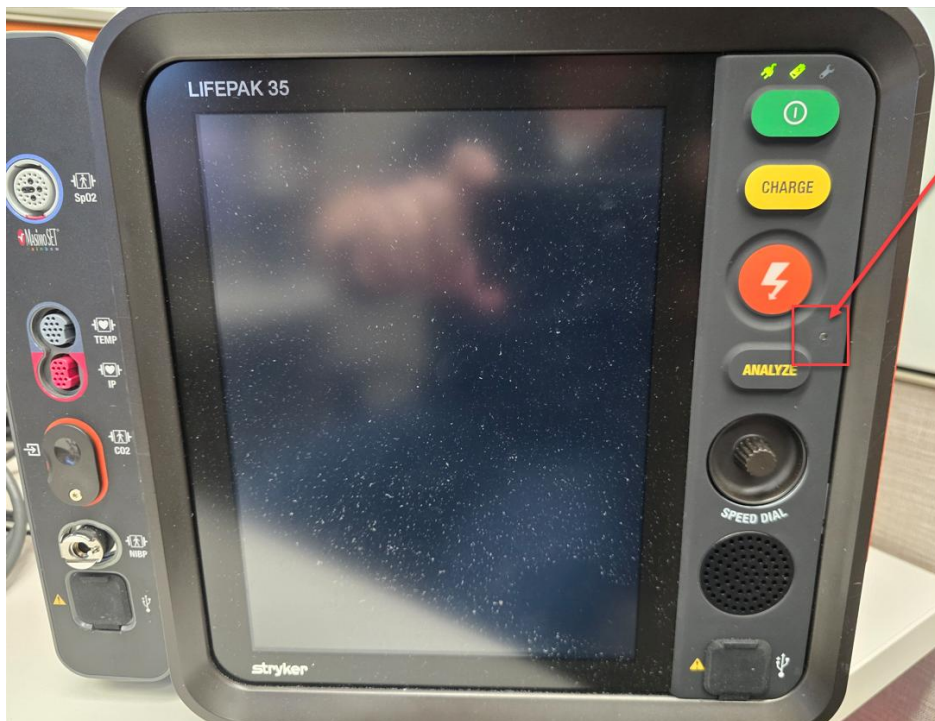
6.5. Ambient Light Sensor Test Failures

Some technicians are experiencing false failures when performing the Ambient Light Sensor test during the LP35 CAPIP. This can happen if the environment you are working in doesn't have sufficient lighting and the light sensor is not able to achieve an adequate baseline reading.

If you are working in an environment that has poor lighting it might help to shine a flashlight at the sensor at the beginning of the Ambient Light Sensor test to allow the application to register an adequate baseline reading.

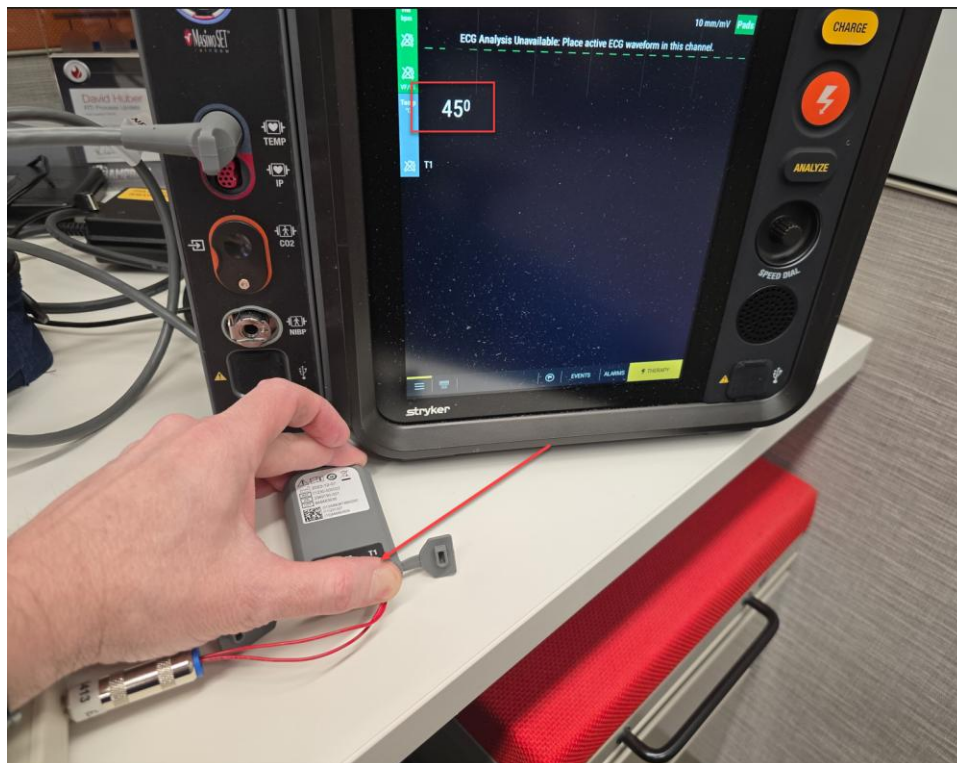
6.6. Temperature Test Failures

Some technicians are experiencing Temperature Test failures while performing the LP35 CAPIP. If you are experiencing this failure, it might be a good idea to verify your test setup in patient mode. Put the device in patient mode and connect the temperature simulator to the cable. Confirm that the simulator value matches the display within 0.2C. If your reading falls outside of this range check to make sure you have a good connection from the test adapter to the cable and see if the reading changes.

If the reading is still out of range, try testing on a different device or using a different temp cable. If it is determined that the device is the issue you can try replacing the temp connector or the system PCB.
