6390 Power-LOAD Post-Crash Inspection Instructions

6390 Power-LOAD Post-Crash Inspection Report

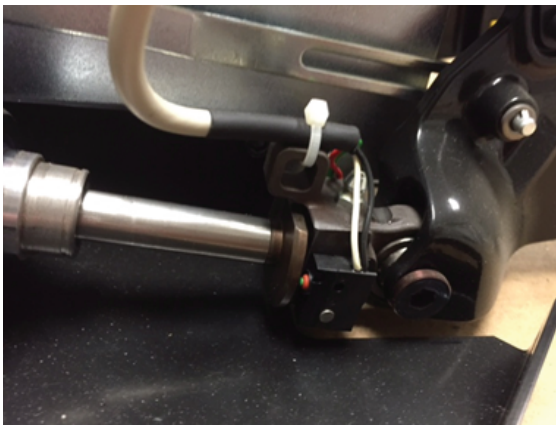
Figure 7:

9. Make sure that the rod end assembly moves freely as the arms are raised and lowered.
10. Inspect the rod end assembly, and its attachment to the lift arms, for cracks or damage (Figure 7 on page 3).
11. Raise and lower the lift arms and make sure that they move freely.
12. Inspect the attachment of the arms to hinge plates for damage or misalignment (Figure 8 on page 3).

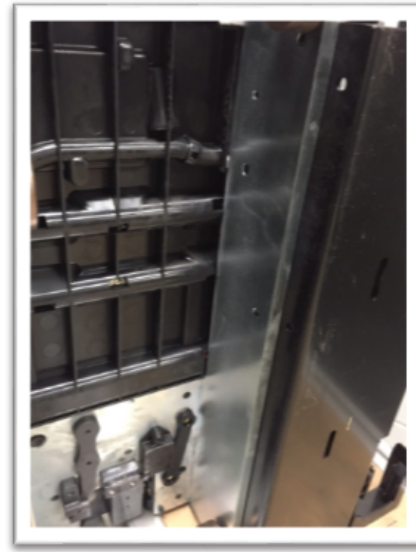
13. Inspect the trolley side plates for cracks or damage (Figure 9 and Figure 10 on page 4).
14. Measure the distance between the two plates on the top and bottom of the trolley; the two measurements should be within 1/16". A cracked side plate, or if the difference is greater than 1/16", indicates that the product has been in a major crash.

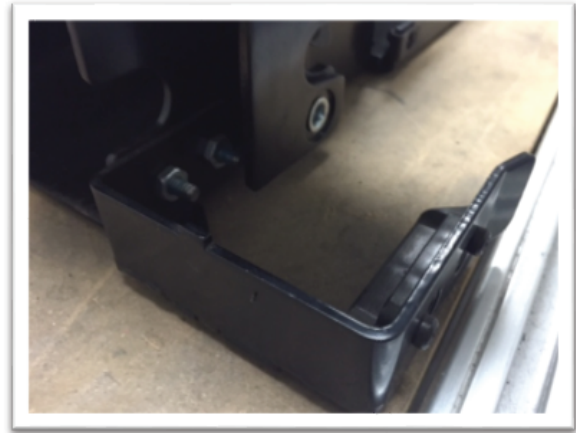
16. Make sure that the load wheel horn guide blocks are present and undamaged (Figure 13 and Figure 14 on page 5).

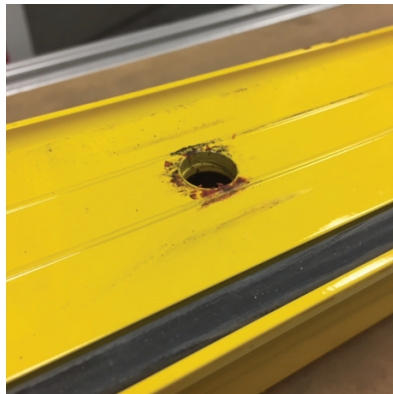
Figure 18:

23. Inspect the bottom of the anchor extrusion for cracks or tearing (Figure 18 on page 6). Minor deformation around the bolt holes is normal, but cracks or tearing indicate that the product has been in a major crash.
24. Examine the floor plate extrusion for damage at the cleat locations (Figure 19 on page 6).

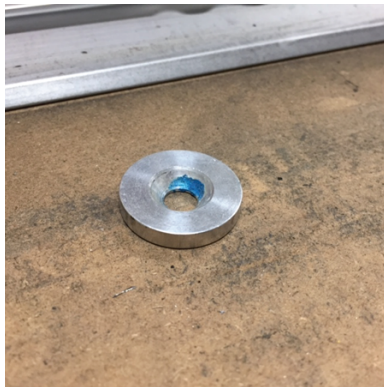
Figure 20:

25. Inspect the cleat locators for damage (Figure 20 on page 7).
26. Using a 1/8" hex wrench, remove each cleat and inspect for cracks or damage (Figure 21 on page 7). Discard the locators and screws. Use the supplied attachment bracket retainer (6390-001-110) and the flat head cap screws (0001-194-000) during reinstallation.

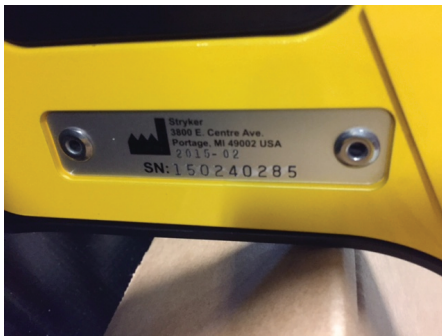
<p>Figure 22: Serial Number Example Picture</p>

Inspector:	Inspection Date:
Service Report Number:	Fastener Configuration: Standard Power-LOAD configuration
Fastener Serial Number: Note: Send a picture of your product's serial number with this report (Figure 22 on page 8).

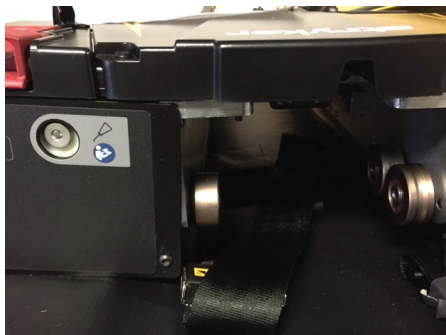
Crash Damage Indicators - inspect the following parts for damage	
Bent Trolley Frame <ul style="list-style-type: none"> Measure the distance between the trolley side plates at the top and bottom. If the measurements are different by more than 1/16", the trolley is deformed. This is more likely to occur after a side crash. Note: Send a picture of the trolley frame with this report (Figure 23 on page 8).

<p>Figure 23: Trolley Frame Example Picture</p>
Comments:	
Deformed Transfer Extrusion <ul style="list-style-type: none"> Pay attention to the ends of the extrusion. Remove the dead stops from the transfer for this inspection. Minor dings and scratches at the edge are acceptable; bending or cracking of the main vertical segments is considered deformation. This is more likely to occur after a front crash. Note: Send a picture of the transfer extrusion with this report (Figure 24 on page 8).
