Title	LIFEPAK 35 Technical Bulletin				Page	Page 1 of 30
QS Process	Field Service, Depot, Aftermarket	Owner	DAVID.HUBER		Doc #	M0000021809
Doc State	Release	Effective Date	07 Jul 2025		Doc Rev	AD
QS Parent	7000180, Servicing Process Work Instruction					
Confidential – Stryker Proprietary Information – Do Not Duplicate

Technical Bulletin

Bulletin Name: TB_LP35_Tech Bulletin

Product Family: LIFEPAK 35

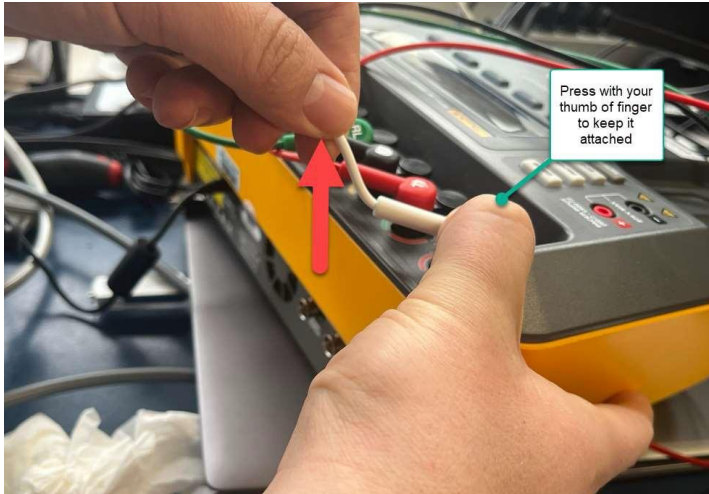
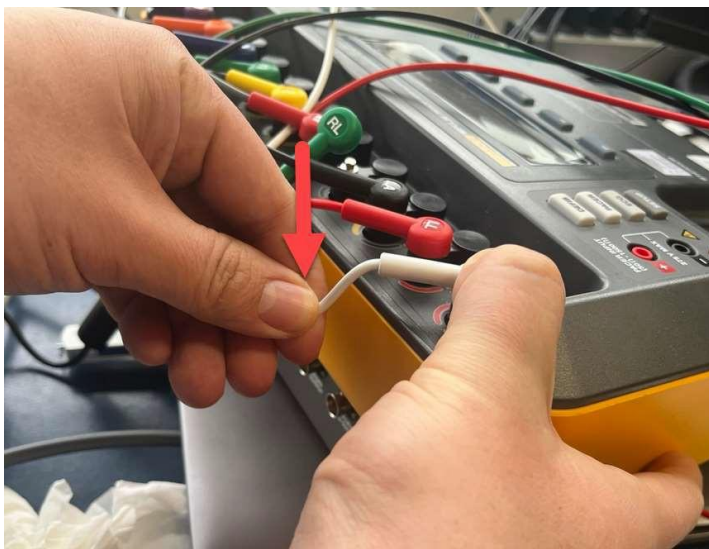
- Customers report
 - ECG goes blank while in use
 - Screen goes blank while in use (prod customer when they indicate screen went blank. Do they mean it went black, or they lost a signal)
- Check the ECG cable- Connect the ECG cable leads to your simulator or 7000 and gently go through each one and wiggle them to see if you lose signal (note loss of some leads will cause other leads to disappear)
- Send cables back to PAC.

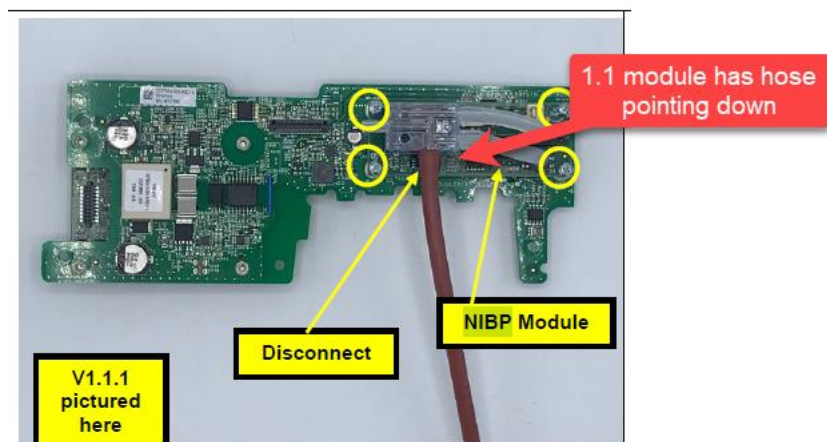
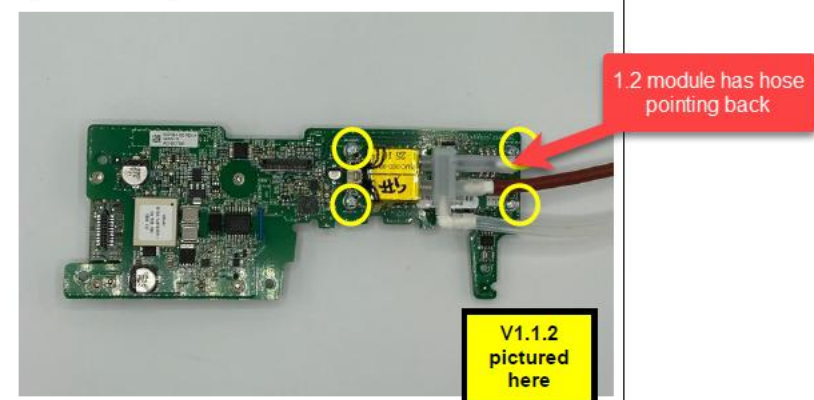
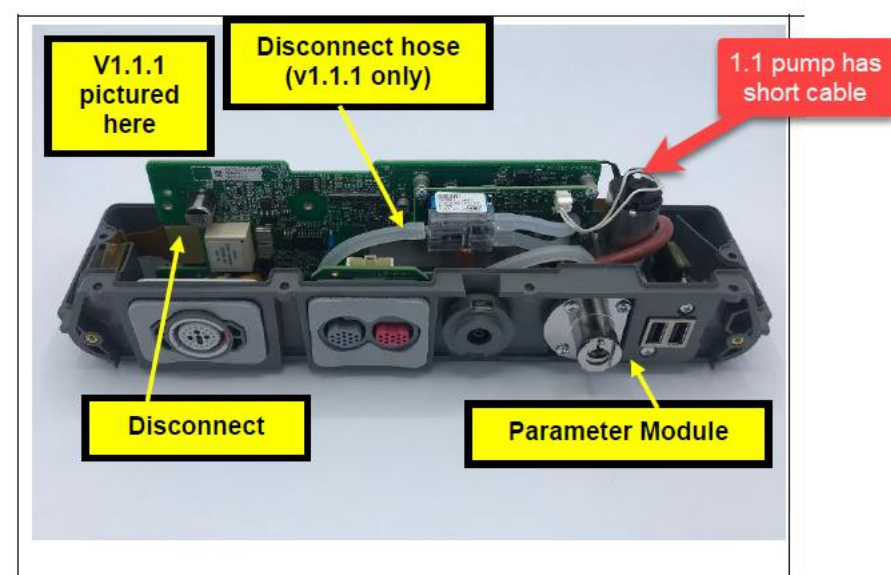
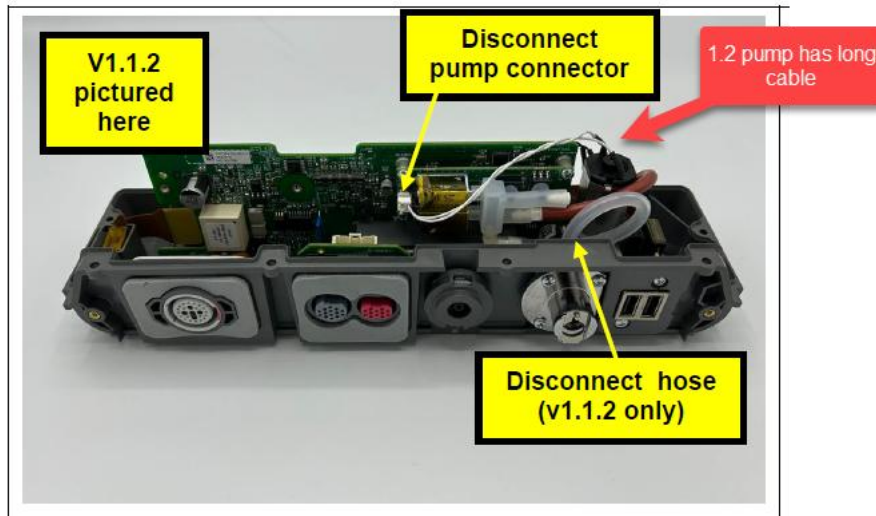
In October 2024 LP35 devices started shipping with version 1.2 of the NIBP Module. The pump in the 1.1 version of the NIBP module is not compatible with the 1.2 version and vice versa. When repairing the NIBP module in a LP35 device make sure that both the pump and module are the same version (1.1 or 1.2).

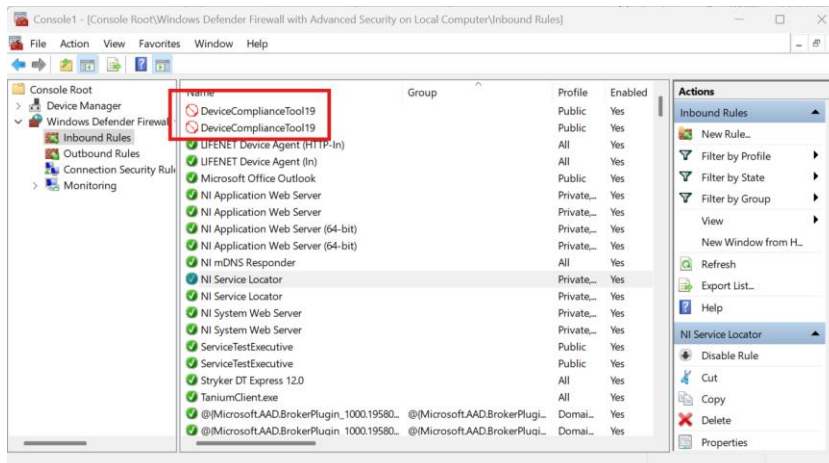
16. If DCT or STE have a red circle with a line through it Windows Firewall is blocking the connection, and it will need to be fixed.
