6392 Performance-LOAD™ Post-Crash Inspection Instructions

6392 Performance-LOAD™ Post-Crash Inspection Report

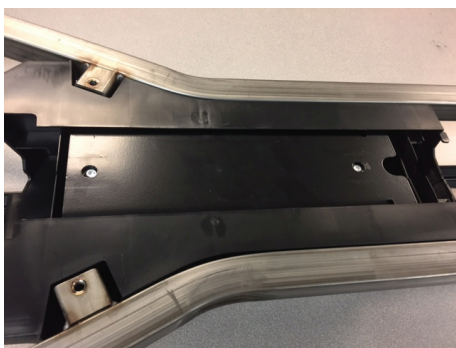
Figure 3:

7. Turn the fastener upside down and inspect the two weldments that connect the outer rails (Figure 3 and Figure 4 on page 2).

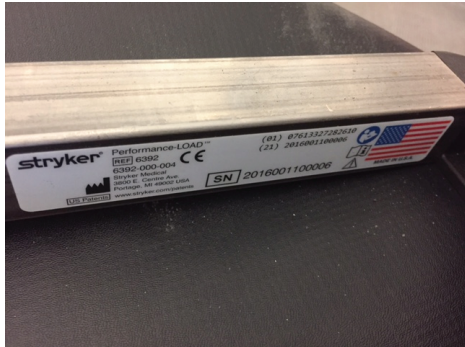
Inspector:	Inspection Date:
Service Report Number:	Fastener Configuration:
Fastener Serial Number: Note: Send a picture of your product's serial number with this report (Figure 6 on page 3).

<p>Figure 6: Serial Number Example Picture</p>

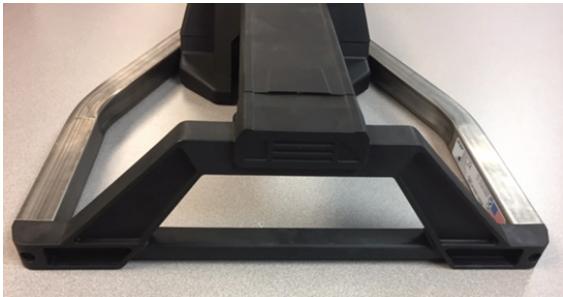
Crash Damage Indicators - inspect the following parts for damage	
Bent Guide Rails <ul style="list-style-type: none"> Place Performance-LOAD on a flat surface and make sure that the rails are not deformed. Note: Send a picture of the guide rails with this report (Figure 7 on page 3).

<p>Figure 7: Guide Rail Example Picture</p>
Comments:	
Deformed Weldments <ul style="list-style-type: none"> Look for weldment deformation at the guide rail connections. Note: Send a picture of the weldments with this report (Figure 8 on page 3).

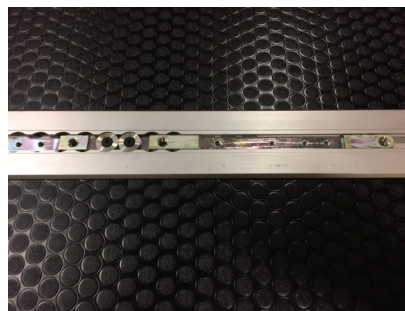
- Inspect the floorplate extrusion for damage around the cleat attachment points. Cosmetic damage may occur when the system is bolted to the floorplate; this damage is acceptable.

Note: Send a picture of the floorplate with this report ([Figure 10 on page 4](#)).

Figure 10: Floorplate Example Picture
