# Model 6506 Power-PRO™ XT post-crash inspection instructions

These instructions are for use with cots that have the Stryker X-restraint package (6500-001-430) or the G-rated restraint package (6500-002-030).

# Model 6506 Power-PRO™ XT post-crash inspection report

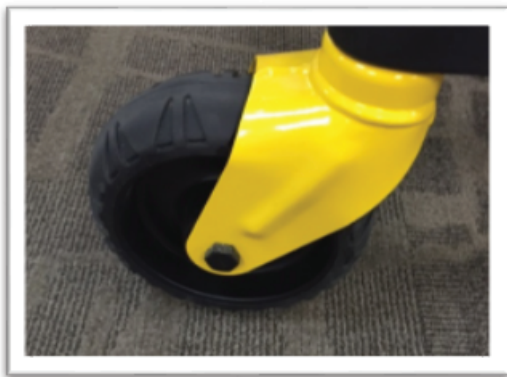
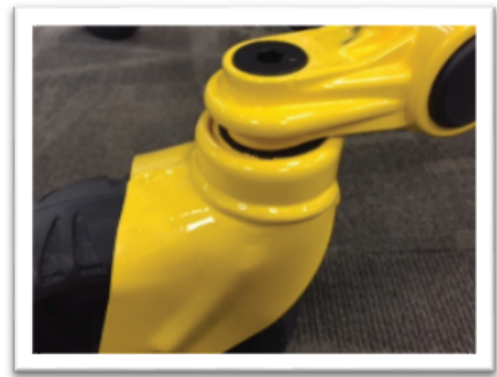
Figure 1 –

2. Make sure that the cot wheels roll smoothly, and that the casters are tight yet rotate freely (Figure 1 and Figure 2). A crushed caster horn indicates that the product has been involved in a major crash.

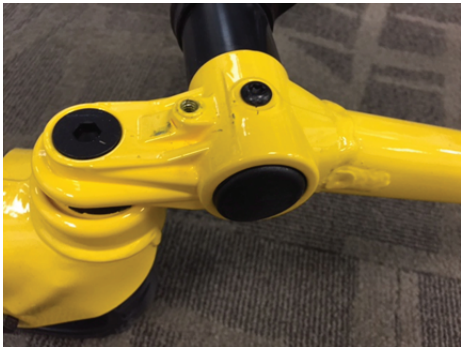
**Figure 3 –**

3. Using a T27 Torx driver, remove the caster mount covers. Inspect the caster mount castings for cracks or deformation (Figure 3).
4. Make sure that the rail clamp post is tightly fastened and that the base tube is not damaged (Figure 4).

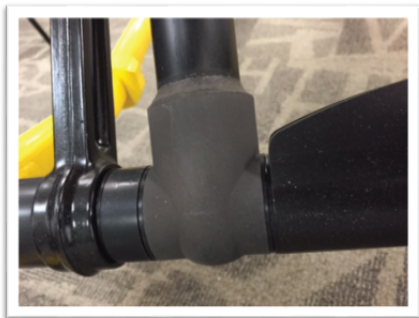
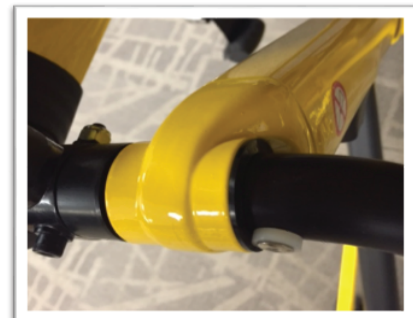
**Figure 7 –**

7. Apply an approximate 250 lb weight to the cot to inspect the X-frame. Check the castings that interface with the base and litter for cracks or damage (Figure 7 and Figure 8). Cracked castings indicate that the product has been involved in a major crash.

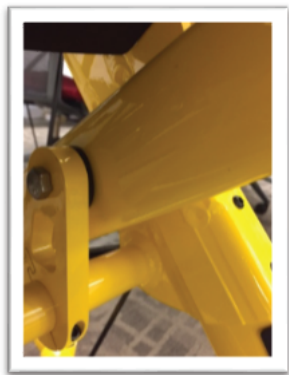
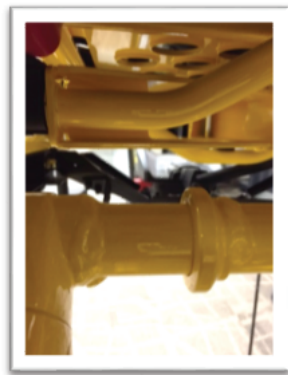
**Figure 9 –**

8. Inspect the welds on the X-frame legs for cracks (Figure 9 and Figure 10).

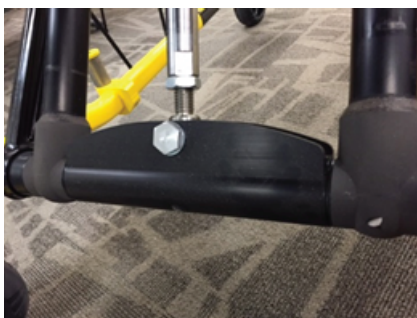
**Figure 11 –**

9. Support both ends of the litter and remove the weight from the cot.
10. Using a 3/4" and a 5/8" hex wrench, detach the rod end of the hydraulic cylinder from the base (Figure 11). Save the rod end.
11. Manually raise and lower the base to make sure that the X-frame moves freely through its range of motion.
12. Reattach the hydraulic cylinder using the wrenches from step 10. Check for damage to the foot end lift bars.
13. Inspect the hydraulic assembly for leaks. Pay attention to the reservoir. Check the hydraulic hoses for wear (Figure 12).

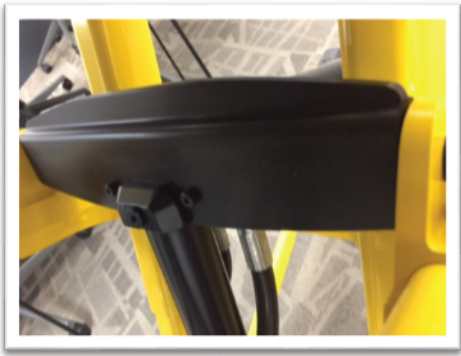
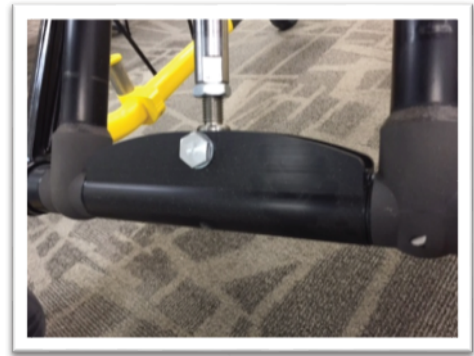
Figure 13 –

14. Inspect the cross tubes at both ends of the hydraulic cylinder for damage (Figure 13 and Figure 14).

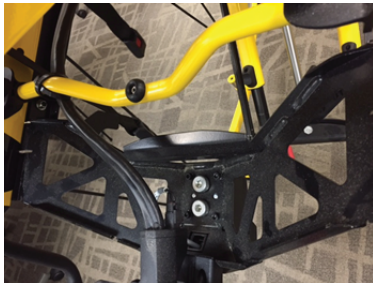
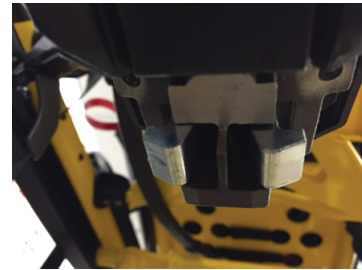
Figure 15 –

15. Make sure that you can raise and lower the cot smoothly. Support both ends of the litter and make sure that the **high speed retract** feature functions. Check the adjustment of the manual release cable. Operate the cot with both sets of switches.
16. Inspect the foot end hitch weldment for cracks or deformation. Pay attention to the welds and the attachment to the litter (Figure 15). Weldment deformation indicates that the product has been involved in a major crash.
17. Inspect the foot end hitch hooks for damage (Figure 16). Squeeze the hooks together and make sure that the spring returns the hooks to their original position.

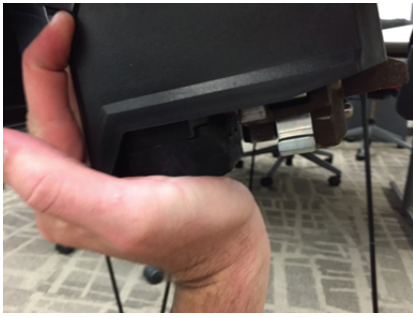
Figure 17 –

18. Press **UP** (↑) on the foot end guide. It should move vertically about 3/4" relative to the weldment. Make sure that the springs smoothly return the foot end guide to the **DOWN** (↓) position (Figure 17).
19. Inspect the plunger on the head end of the guide. Press the plunger in and make sure that the return spring moves it back to the out position. Check for interference between the casting and the base tube in the lowest position (Figure 18).

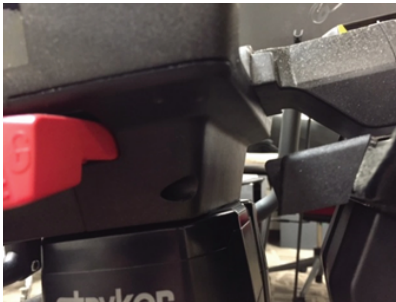
Figure 19 –

20. Check the rear of the electronics enclosure for damage. Make sure that the battery slides in and out smoothly and that the latch mechanism locks the battery into the enclosure. Check for contact between the enclosure and the foot end hitch (Figure 19).

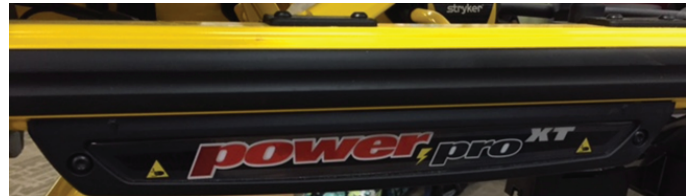
Figure 20 –

21. Inspect the sensor housings for damage and make sure that they are mounted tightly to the outer rails (Figure 20).

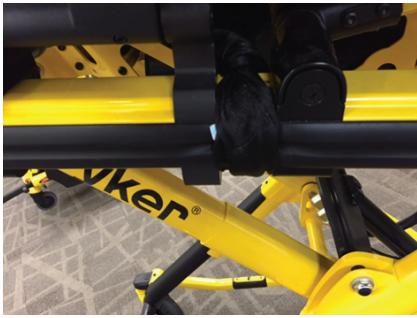
**Figure 21 –**

22. Check for deformation of the outer rails at the restraint attachment locations (Figure 21). Deformation of the outer rail(s) indicates that the product has been involved in a major crash.

**Note** - A telescoping head section is a good indication of deformation.

- Check for a bent or crushed outer rail at the restraint attachment locations. Loosen or remove the restraints to inspect. The telescoping head section release should operate properly, and the head section should be able to extend and retract smoothly.

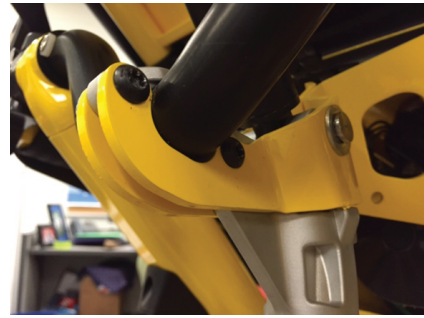
**Figure 22 –**

23. Inspect the motor mounts for deformation or damage. The motor mount attachment to the V-tube should be centered on the V. Pay attention to deformation at the cylinder pivot (Figure 22). Deformation of the motor mounts, which prevent the cot from locking into the **Performance-LOAD** fastener, indicates that the product has been involved in a major crash.

- Damage to the motor mount may appear on cots crashed with a **Performance-LOAD** fastener. Front crashes create damage under the seat section, near the motor. Side crashes can twist the motor mount near the Fowler cylinder pivot. Make sure that the attachment to the v-tube is centered.

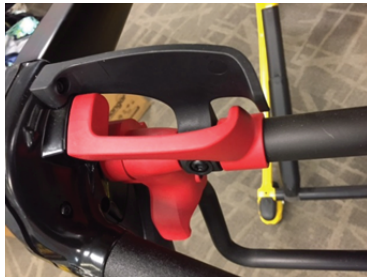
**Figure 23 –**

24. Make sure that the head section telescopes in and out freely. The head section should lock in the fully extended and fully retracted positions. Check for damage to the head section release handles and guards (Figure 23).
25. Inspect the load wheel horns. Check for cracks or damage, that the horns are tight, and that the wheels roll freely (Figure 24).

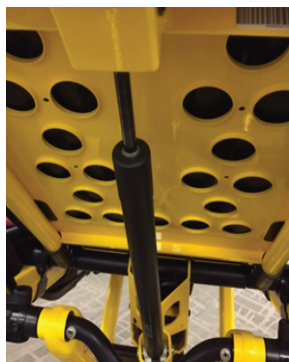
**Figure 25 –**

26. Make sure that the safety bar rotates freely and returns to the neutral position.
27. Raise and lower the Fowler to make sure that it moves freely and that the Fowler cylinder release is adjusted (Figure 25). Check the Fowler cylinder for leaks or damage.
28. Inspect the litter pivots for cracks or damage (Figure 26).

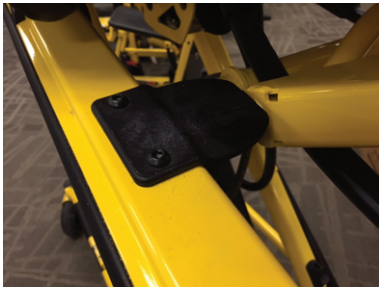
Figure 27 –

29. Check the Gatch/Trendelenburg attachment for cracks or damage (Figure 27).
30. Inspect the litter pivots for cracks or damage (Figure 28).

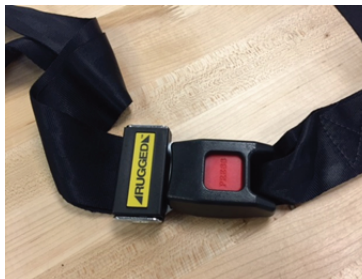
Figure 29 –

31. Make sure that the Gatch/Trendelenburg move freely and that the release mechanism functions.
32. Replace the cot restraints (Figure 29).

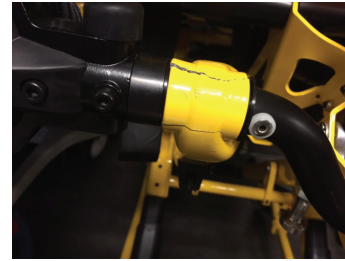
- Check for cracks on the castings that secure the inner legs to the litter at the v-tube. This damage occurs after front and side crashes with a **Performance-LOAD** fastener. If a casting cover is present, remove and inspect the casting.

**Figure 36 – Litter pivot casting example picture**

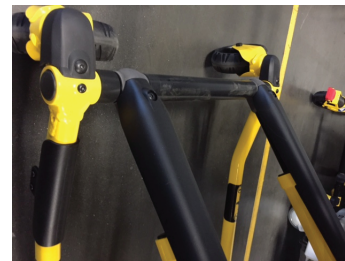
- Check the cross tube at the head end side of the cot base for deformation. This damage may occur in a front crash with the **Power-LOAD** fastener. Damage to the plastic cover is not a failure; rotating the plastic cover is a good way to check if the tube is bent.

**Figure 37 – Head end base tube example picture**

5. Inspect the base tube welds for cracks (Figure 5).
6. Make sure that the head end base tube is not bent (Figure 6). Superficial damage to the outer plastic cover is acceptable. A bent base tube indicates that the product has been involved in a major crash.
