## Isolibrium® PE support surface

### Maintenance Manual

REF 297300000000

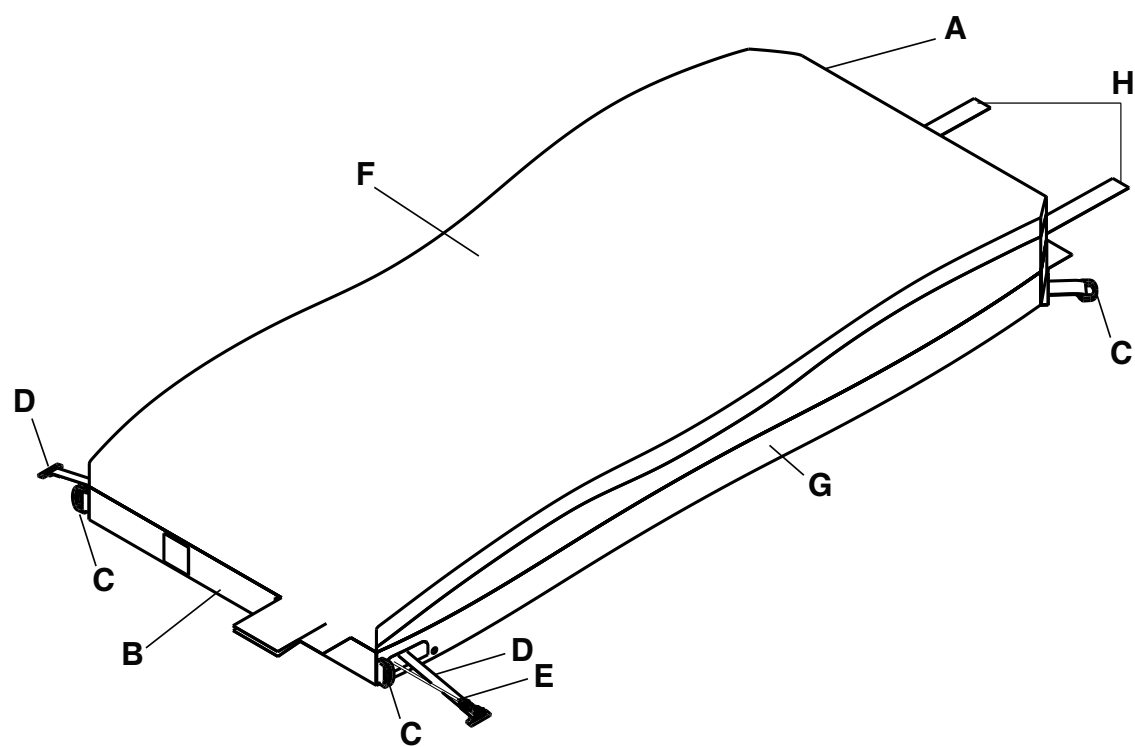
Product illustration

A	Head end
B	Foot end
C	D-ring
D	CPR strap
E	Power/data cable

F	Top support surface cover
G	Bottom support cover
H	Retainer strap (D-ring not shown)
I	Four handles on the support surface (not shown)

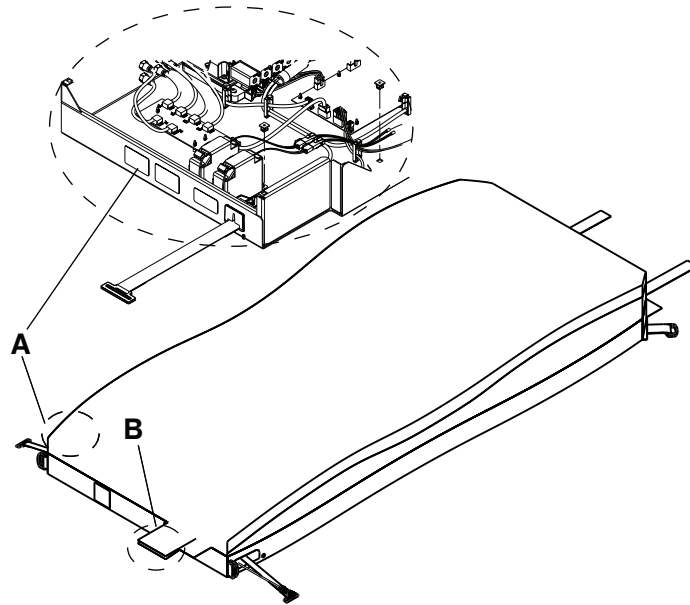
## Serial number

The serial number (A) for your support surface is located on the patient right side of the foot box on the specification label. Unzip the support surface top cover to access the specification label. The serial number (B) is for the support surface cover.

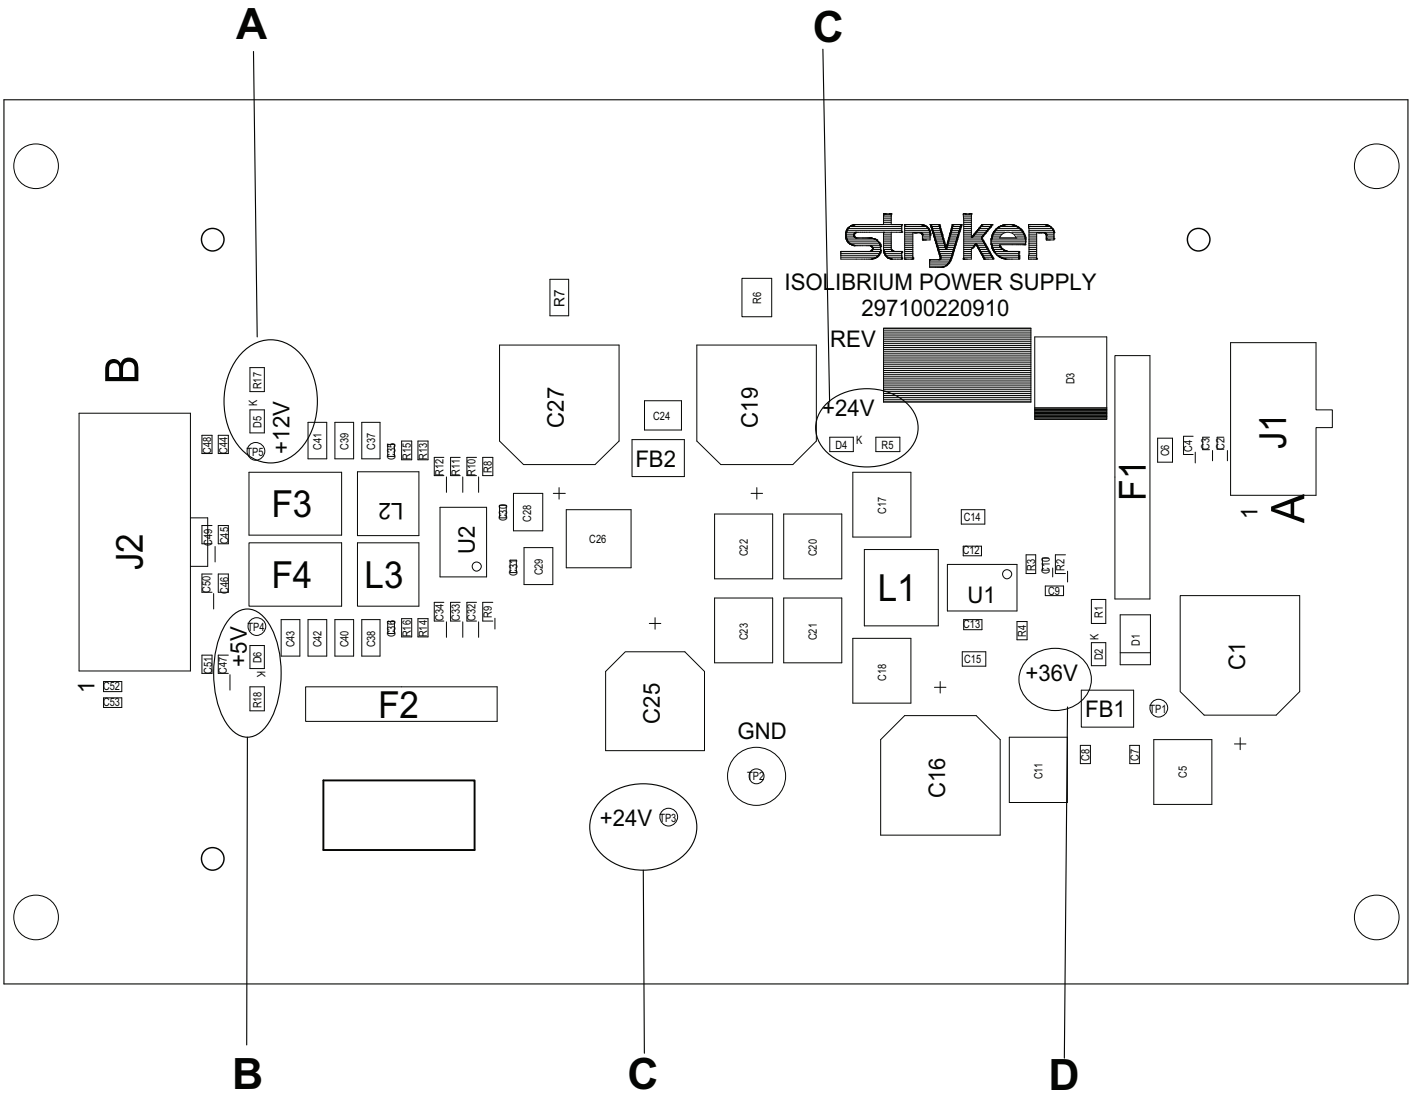
297100220910 Rev AF (Reference only)

Power supply assembly

Location	Voltage	Positive lead	Negative lead	LED indicator
A	+12VDC	TP5	GND	D5
B	+5VDC	TP4	GND	D6
C	+24VDC	TP3	GND	D4 (location E)
D	+36VDC	TP1	GND	D2

Problem	Possible Cause	Solution
	Check the VDC voltage at the test points on the power supply	<ol style="list-style-type: none"> <li>1. Check the input into the power supply <ul style="list-style-type: none"> <li>• 36V – Probe between TP1 and the GND lug</li> </ul> <p><b>Note</b> - If no voltage is present on the input, check bed configurations, cable continuity to the Main Controller in the electronics box on the bed, and that the support surface is plugged into the bed.</p> </li> <li>2. Check output voltages on the power supply <ul style="list-style-type: none"> <li>• 24V – Probe between TP3 and the GND lug</li> <li>• 12V – Probe between TP5 and the GND lug</li> <li>• 5V – Probe between TP4 and the GND lug.</li> </ul> <p><b>Note</b> - If the voltage on A, B, or C are not correct, change out the power supply.</p> </li> </ol>

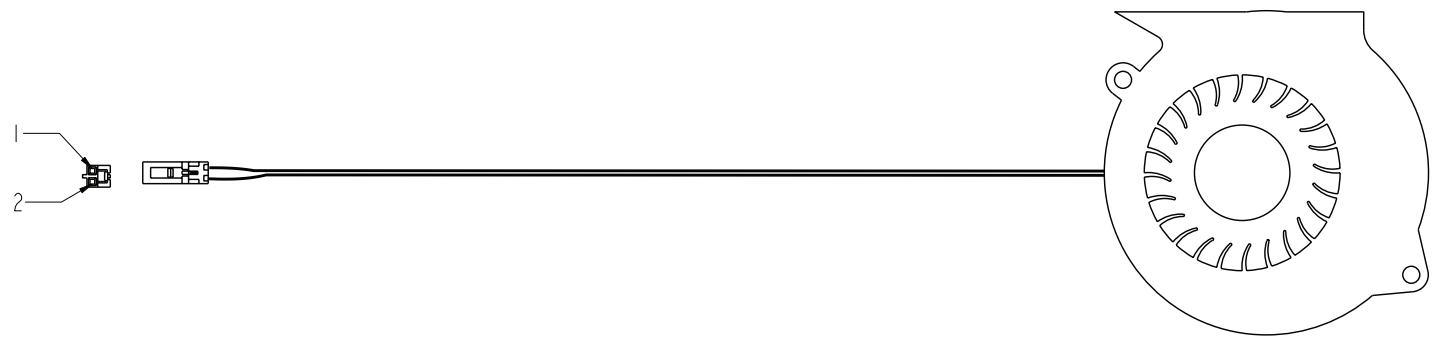
2971-021-188 Rev C (Reference only)

## Fans and cable assembly

Item	Color
1	Red
2	Blue

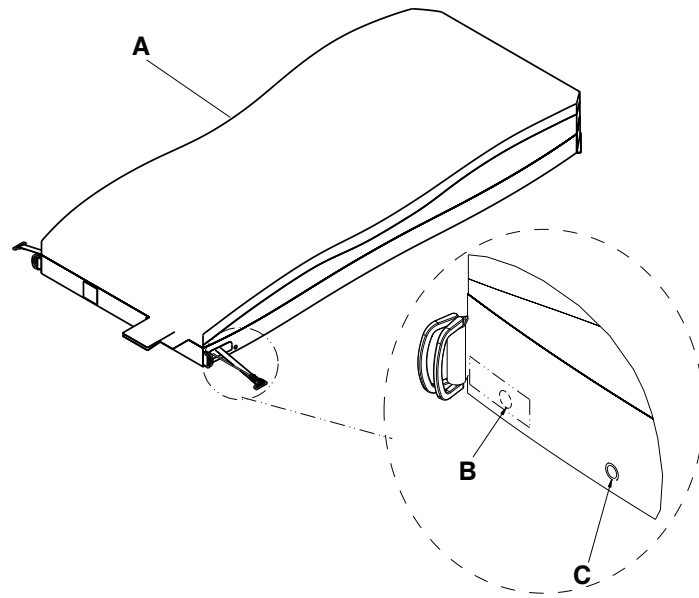
**Figure 1 – Top cover**

- On install, reconnect the corner retainers. Place the strap below each D-ring at the foot end corners and snap the cover.
- The zipper starts on the patient right side near the foot end.

8. Insert a zipper pull tool or equivalent through the hole in the zipper slider to unlock.
9. Use the zipper pull tool or equivalent, to unzip the support surface top cover (A) from the bottom (Figure 1).
10. Remove and discard the top cover.
11. Reverse to install the new cover.

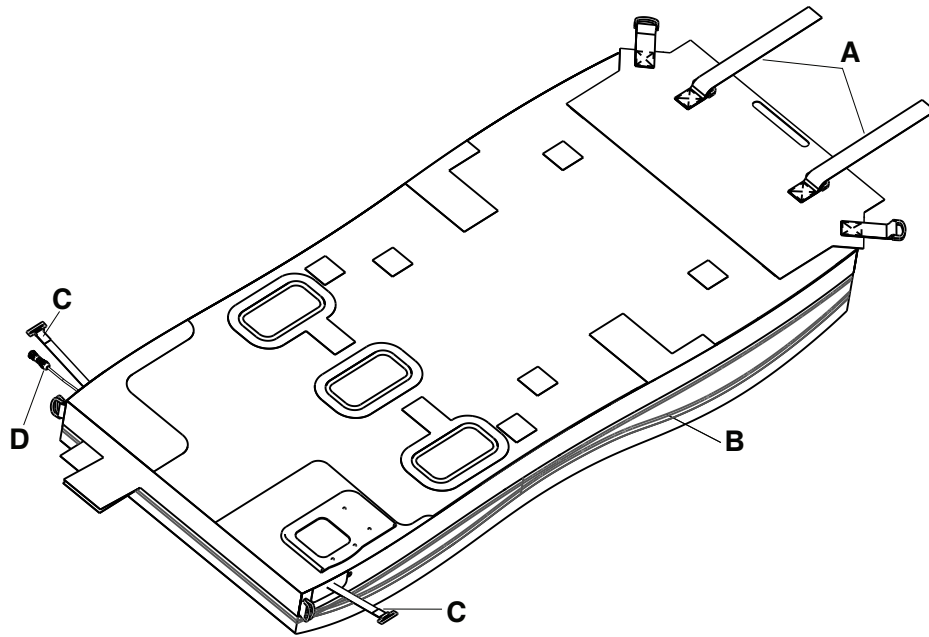
**Figure 2 – Bottom support surface cover**

1. Apply the brakes on the **ProCuity** bed frame.
2. Unplug the support surface power/data cable from the bed.
3. Remove the power/data cable from the strain relief bracket.
4. Remove the headboard and footboards.
5. Lower all the siderails.
6. Loosen and remove the retainer straps (A) that hold the support surface to the Fowler (Figure 2).
7. Before you turn over the support surface, place a protective sheet on the surface where you will rest the support surface top.
8. Using two operators, turn the support surface over.

9. Unsnap the four corner cover snaps.
10. Unsnap the two secure snaps at the right and left foot end corners.
11. Insert a zipper pull tool or equivalent through the hole in the zipper slider to unlock.
12. Grasp the zipper pull tool or equivalent and pull to unzip the bottom cover from the top cover (B) (Figure 2).
13. Feed the CPR release straps (C) and power/data cable (D) through the bottom cover (Figure 2).
14. Unsnap the two snaps that secure the bottom support surface cover to the foot box.

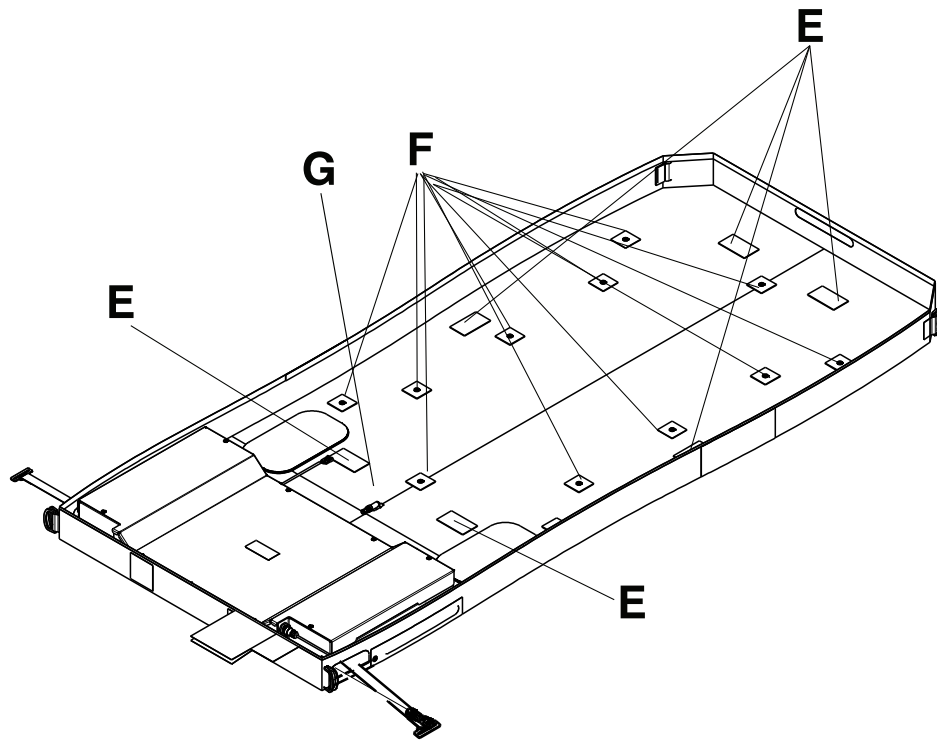
**Figure 3 – Pod Velcro® and snap retainers**

15. Starting at the head end of the support surface, separate the six **Velcro®** patches from the bottom cover (E) (Figure 3).
16. In a gentle motion, unsnap the twelve snaps and separate the **Velcro®** from the left and right sides of the turn bladder (F) (Figure 3).

17. Detach the foot end foam crib from the bottom cover.
18. Disconnect the exhaust tube quick disconnect (G) from the bladder assembly (Figure 3).
19. Remove and discard the bottom cover.
20. Reverse to install the new bottom cover.

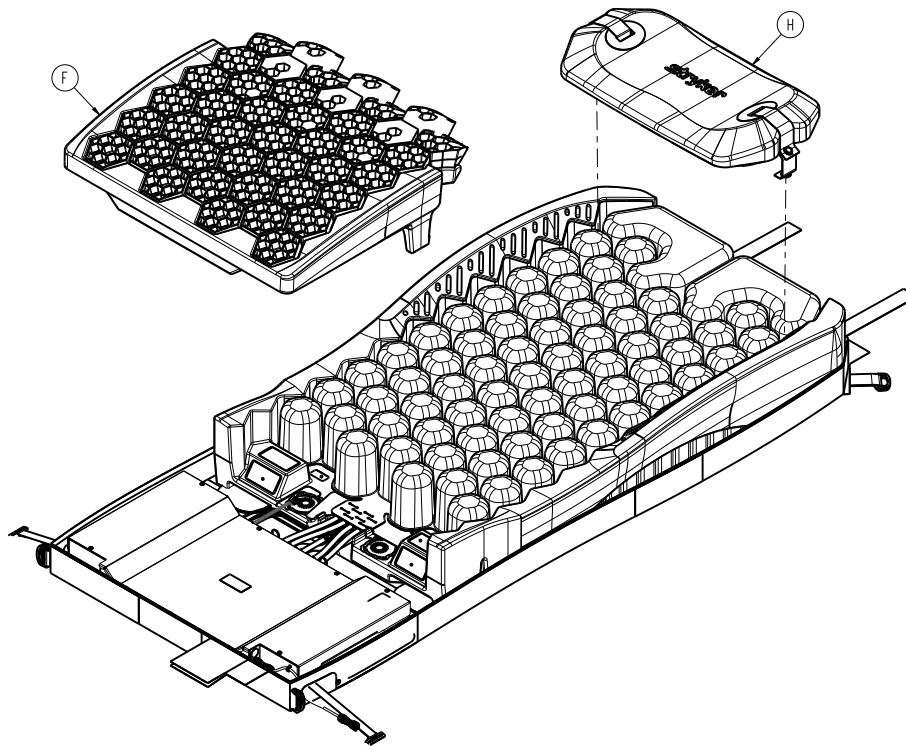
**Figure 4 – Gel crib, pillow, and quick disconnect fitting**

1. Remove the top cover. See *Cover replacement, top* (page 22) .
2. Unsnap the pillow (H) from the left and right side of the pod assembly (Figure 4). Save the pillow.
3. Separate the six **Velcro®** connectors that hold the foot section gel crib to the pod assembly.
4. Lift upward and remove the foot section gel (F) (Figure 4). Save the gel crib.

5. Disconnect the quick disconnect fitting (Z) (Figure 4).
6. Remove the two retaining pins (A) from the hose quick connection on the foot box assembly (Figure 5). Save the pins.

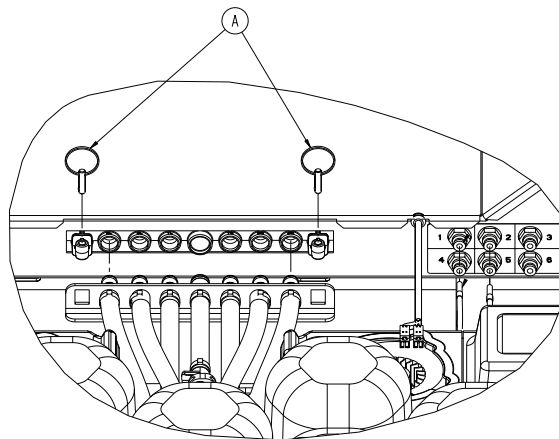
**Figure 5 – Retaining pins**

7. Grasp both sides of the hose quick connection on the pod assembly and pull toward the head end of the support surface to disconnect from the foot box manifold.
8. Disconnect the four pod sensor hoses (Y) (one blue, two yellow, four green, and five orange) from the foot box. Push into the coupling and pull out each of the hoses (Figure 6).

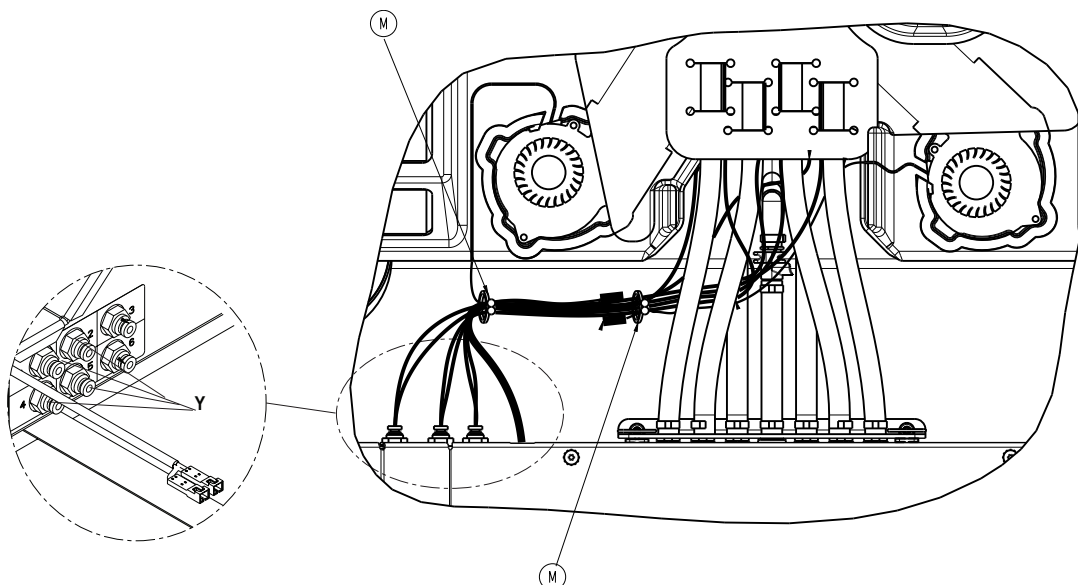
**Figure 6 – Pod sensor hoses and purse lock wire tie**

- Do not bend or kink the pod sensor hoses.
- Pay attention to the sensor hose position, insertion color, and label numbers.
- During reinstall, insert the hose. Once you hit a stop, continue to push until you reach a hard stop.

9. Remove the sensor hoses from the purse lock wire ties (M) (Figure 6).
10. Reach under the pod assembly (C) from the patient's right side near the middle to access the turn bladder. Disconnect the turn bladder quick disconnect. Repeat for the patient's left side (Figure 7).

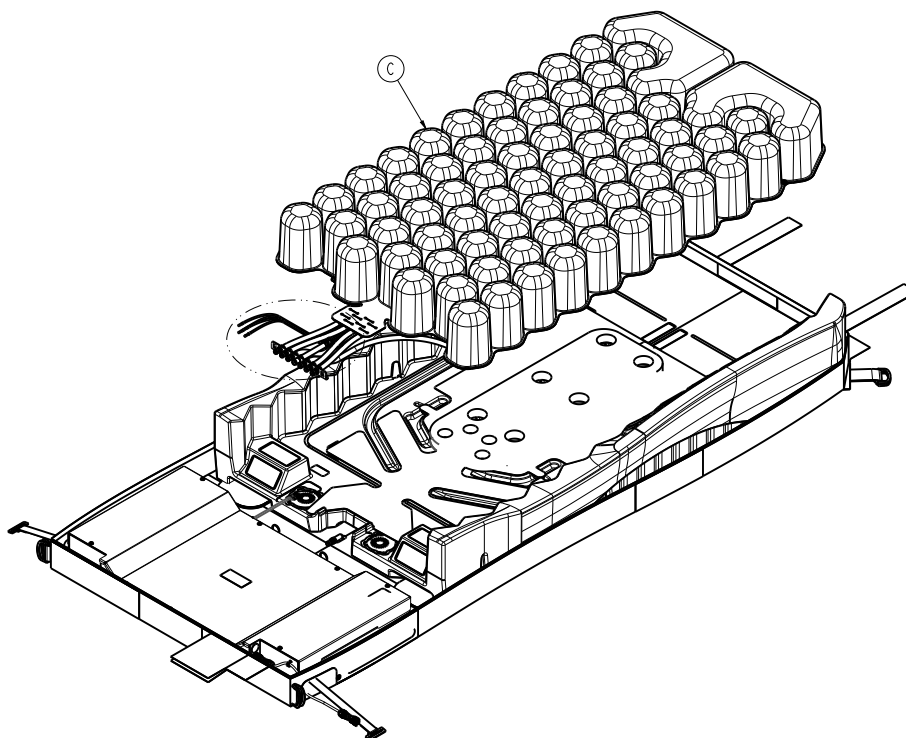
**Figure 7 – Pod assembly**

11. Separate the **Velcro®** retainers from the head end of the pod assembly (C) and feed the turn bladder hose quick connection through the foam crib.
12. Remove and discard the pod assembly (C) (Figure 7).
13. Reverse steps to reinstall.

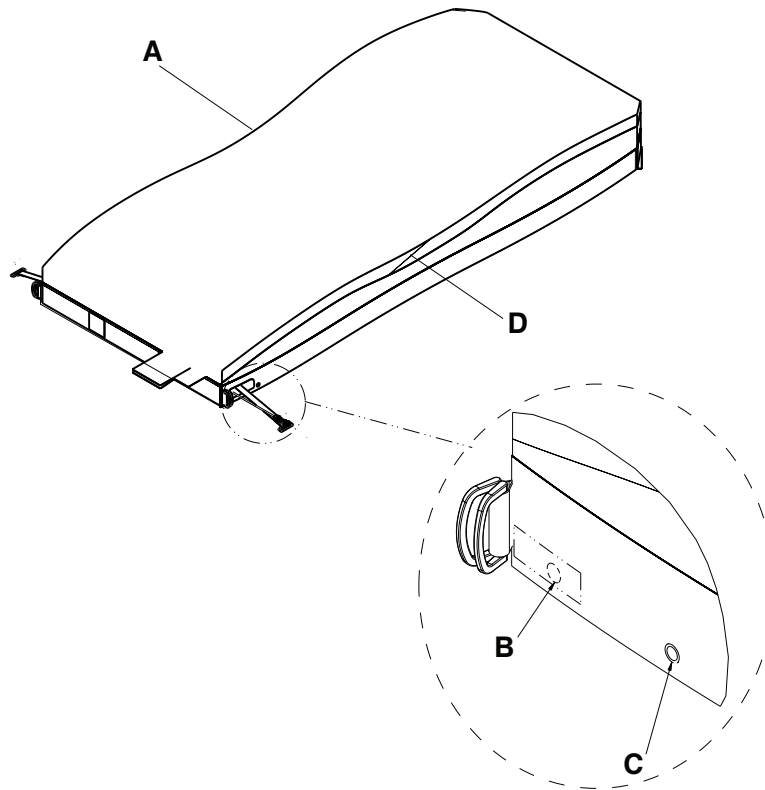
**Figure 8 – Top cover**

1. Apply the brakes on the **ProCuity** bed frame.
2. Unplug the support surface power/data cable from the bed.
3. Remove the headboard and footboards and set aside.
4. Lower all the siderails.
5. Unsnap the two secure snaps (C) at the foot end corners (Figure 8).
6. Unsnap the two foot end corner retainers (B) (Figure 8).
7. Insert a zipper pull tool or equivalent through the hole in the zipper slider to unlock.
8. Using the zipper pull tool or equivalent, unzip the support surface top cover from the bottom cover (A) (Figure 8) and stop unzipping at the middle of the opposite side (D).

**Note** - The zipper starts on the patient right side near the foot end.

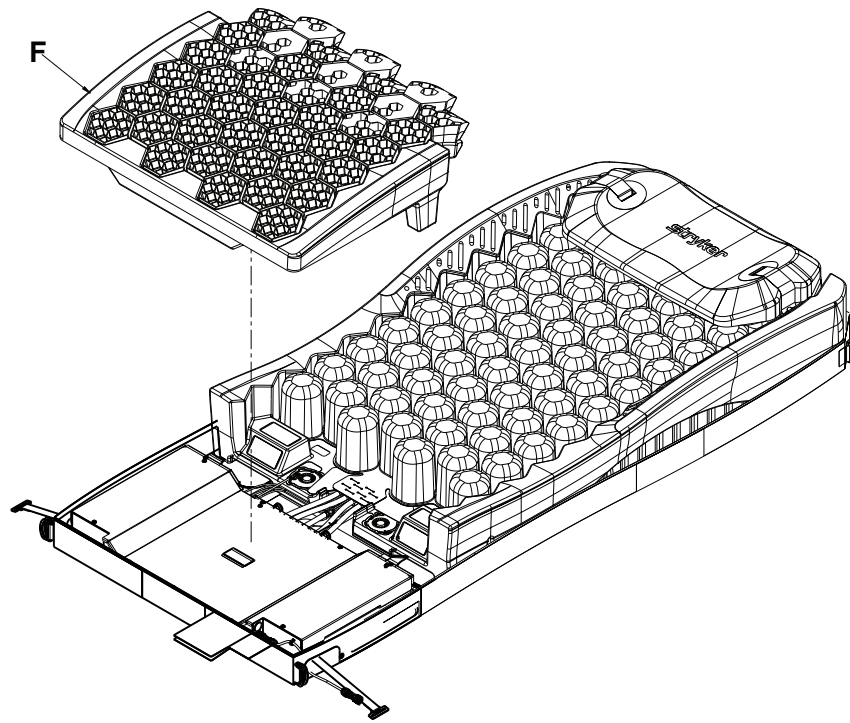
**Figure 9 – Gel crib**

9. Fold the cover up toward the head end.
10. Separate the six **Velcro®** connectors that hold the foot section gel crib to the pod assembly.
11. Lift upward and remove the foot section gel (F) (Figure 9). Save the gel crib.
12. Unsnap the two snaps that secure the bottom support surface cover to the foot box.

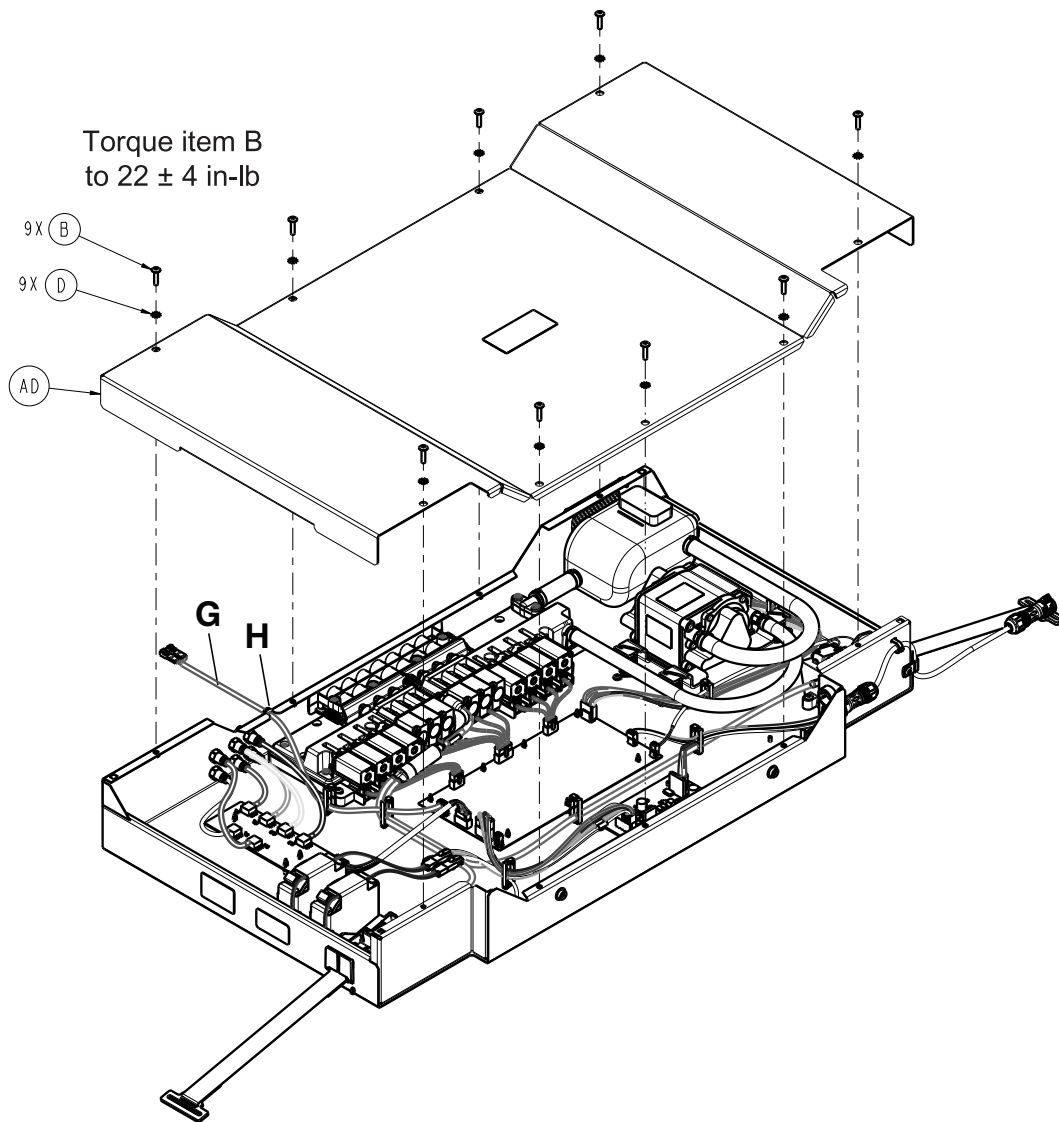
Figure 10 – Foot box cover

13. Using a T15 Torx driver, remove the nine ground screws (B) and the nine star washers (D) (Figure 10). Save the ground screws and the star washers.

- During reinstall, tighten the screws equally and do not over tighten. Torque item B to  $22 \pm 4$  in-lb.
- During reinstall, check the LAL fan cable (G) and grommet (H) are in place before replacing the foot box cover (Figure 10).
- After installation, remove the zipper pull tool or equivalent from the zipper.

14. Remove the foot box cover (AD) (Figure 10). Save the foot box cover.

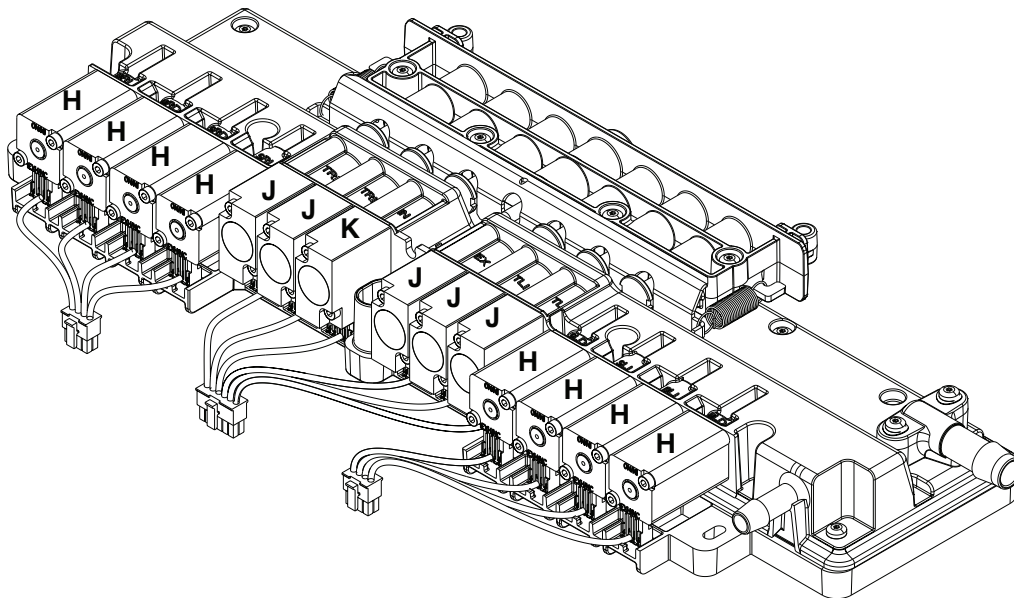
**Figure 11 – Solenoid valve**

1. See *Accessing the foot box cover* (page 28).
2. See *Protecting against electrostatic discharge (ESD)* (page 22)).
3. Using the supplied torque driver, remove the two screws that secure the solenoid valve (H, J, or K) to the manifold assembly (Figure 11). Save the screws.

**Note** - During installation tighten the screws equally. Use the supplied torque driver and torque the screws to 4.4 in-lb.

4. Remove the solenoid valve.
5. Disconnect the connector for the solenoid valve.

**Note** - Inspect the replacement solenoid valve to make sure that the O-ring is in place. If the O-ring is not in place, transfer the O-ring from the removed solenoid valve to the supplied solenoid valve.

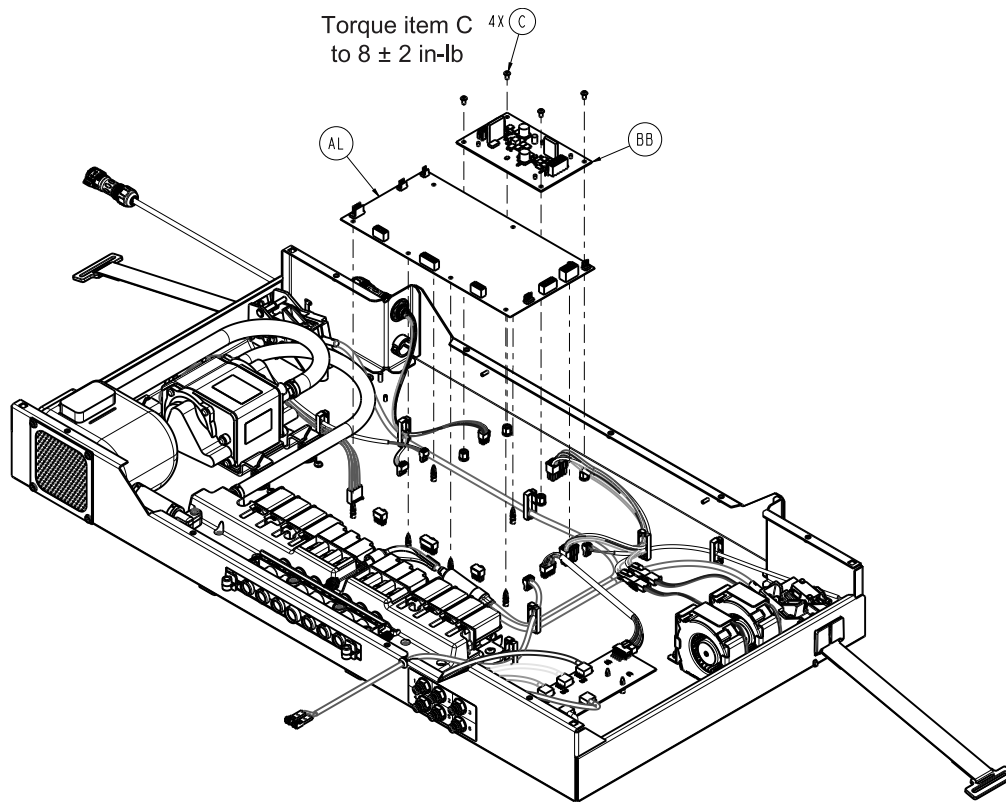
Figure 12 – Power board

1. See *Accessing the foot box cover* (page 28).
2. See *Protecting against electrostatic discharge (ESD)* (page 22)).
3. Using a T10 Torx driver, remove the four screws (C) that secure the power board (BB) to the foot box (Figure 12). Save the screws.

**Note** - During reinstall, torque (C) to  $8 \pm 2$  in-lb.

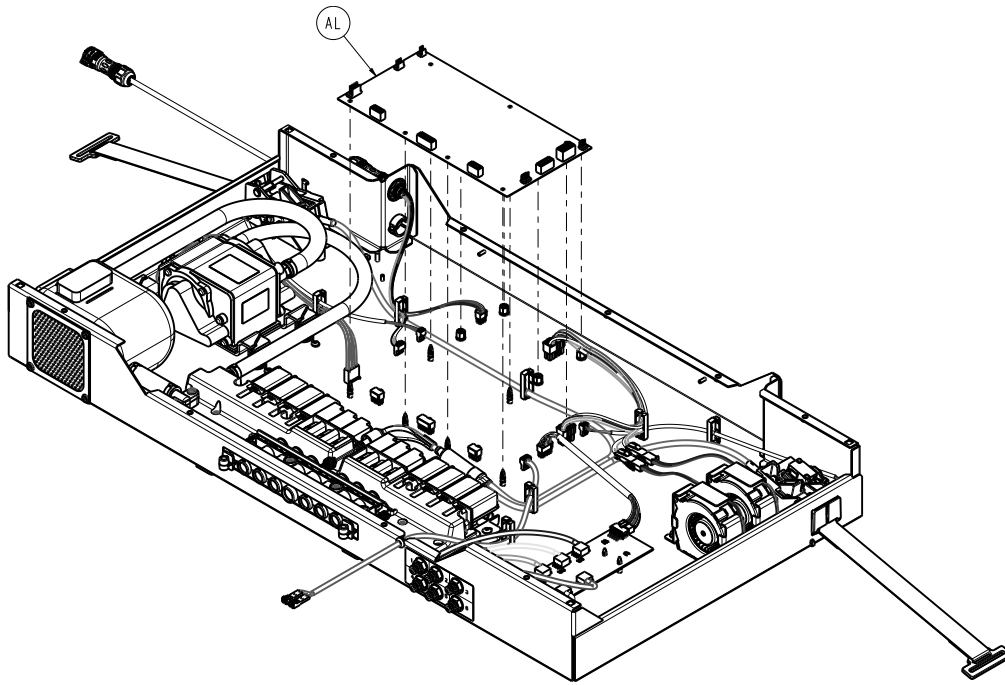
**Figure 13 – Main board**

1. See *Accessing the foot box cover* (page 28).
2. See *Protecting against electrostatic discharge (ESD)* (page 22)).
3. Remove all wiring connections from the main board (AL) (Figure 13).

4. Using needle nose pliers, apply a slight upward pressure on the main board to unclip the seven plastic standoffs.

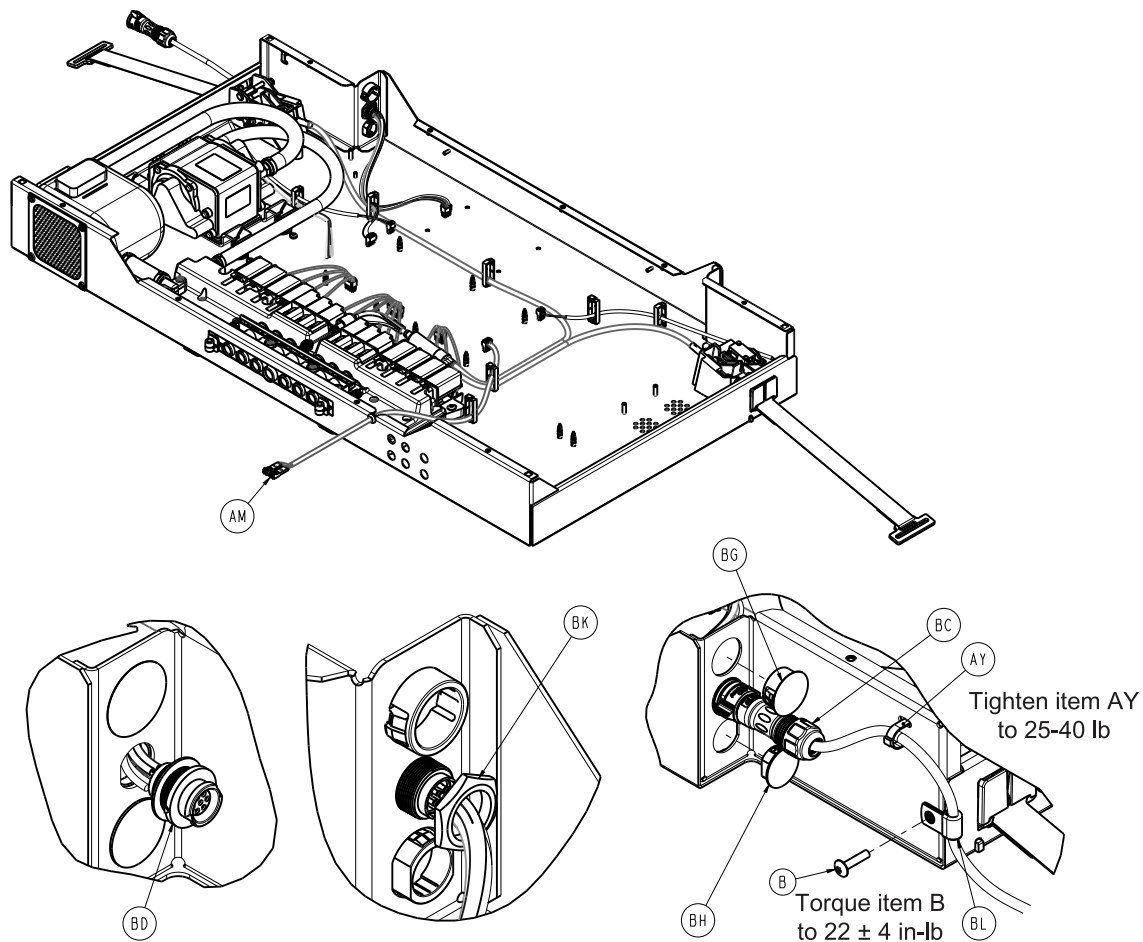
**Figure 14 – Power/data cable connector**

1. See *Accessing the foot box cover* (page 28).
2. Using your fingers, disconnect the power/data cable connector (AP) from the foot box and rotate the turn-lock counterclockwise (Figure 14).
3. Using a 7/8" combination wrench, remove the retention nut (BK) on the power/data cable connector that secures it to the foot box. Save the nut.

4. Remove and discard the power/data cable connector.
5. Reverse steps to reinstall.

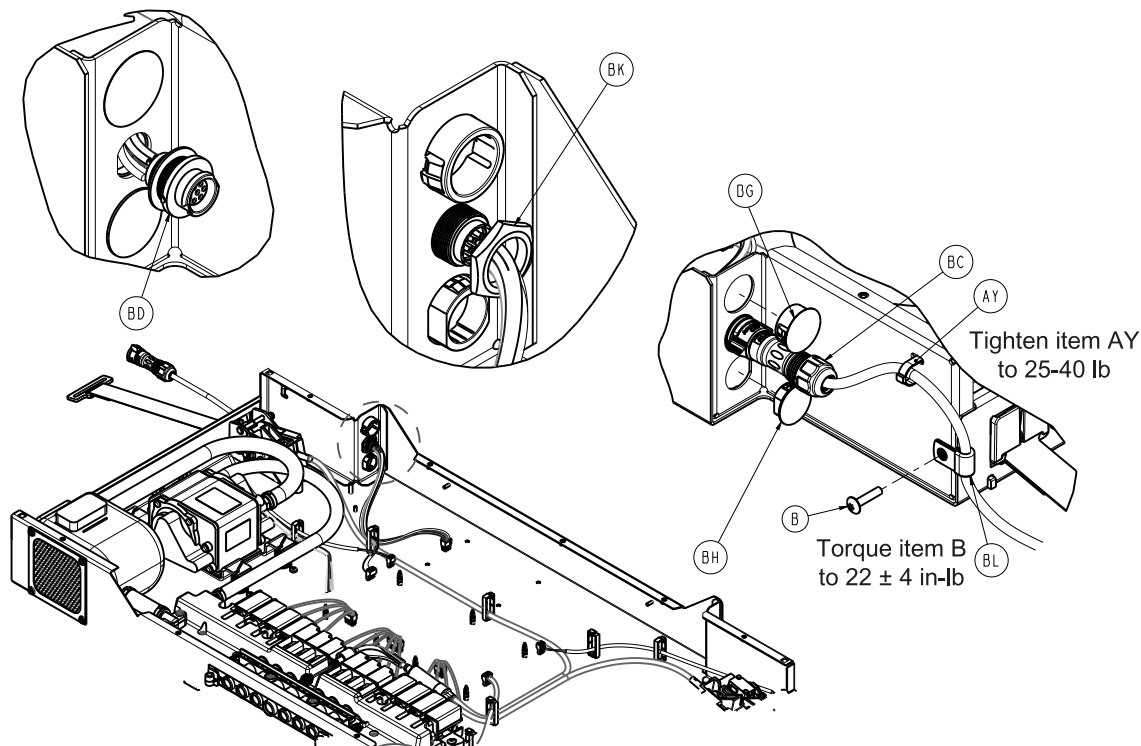
**Figure 15 – Power/data cable**

5. Turn off the battery disconnect switch to turn the bed off.
6. See *Accessing the foot box cover* (page 28).
7. Using diagonal pliers, cut the cable tie (AY) that secures the power/data cable (BC) to the foot box. Discard the cable tie.

**Note** - During installation, tighten the cable tie (AY) to 25 - 40 lb.

8. Using a T15 Torx driver, remove the screw (B) from the cable clamp (BL) (Figure 15). Save the screw.
  9. Remove and save the cable clamp (B) (Figure 15).
  10. Unlock both connectors (BD, BK) and the ends of the power/data cable (BC) to disconnect the power/data cable. Discard the power/data cable.
  11. Reverse steps to reinstall. Orient the cable clamp (BL) as shown (Figure 15).
- Note** - During reinstall, torque the screw (B)  $22 \pm 4$  in-lb.
12. Route the power/data cable (BC) through the bottom cover (Figure 16).

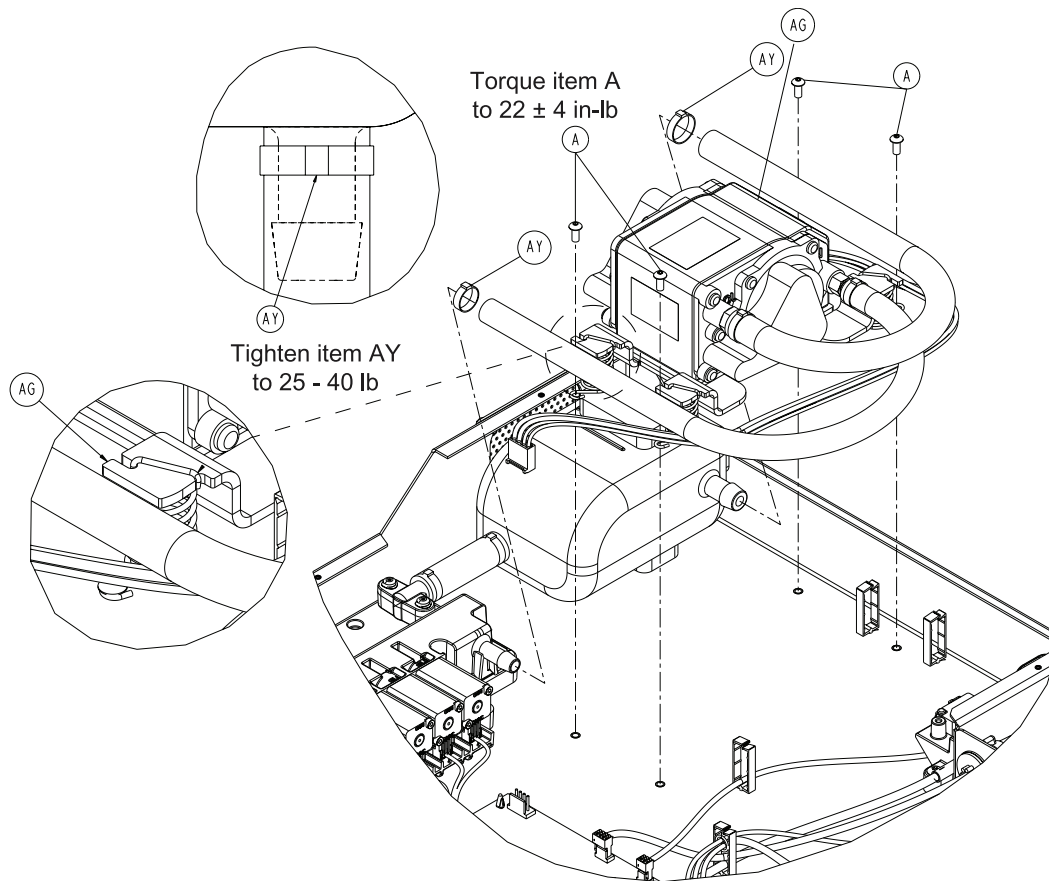
**Figure 17 – Pump assembly**

**Note** - During installation, before you cut the end off of the cable tie, use the diagonal pliers to pry the slack out of the cable tie (one to two clicks).

5. Using a T15 Torx driver, remove the four screws (A) that secure the pump assembly (AG) to the foot box (Figure 17). Save the screws.

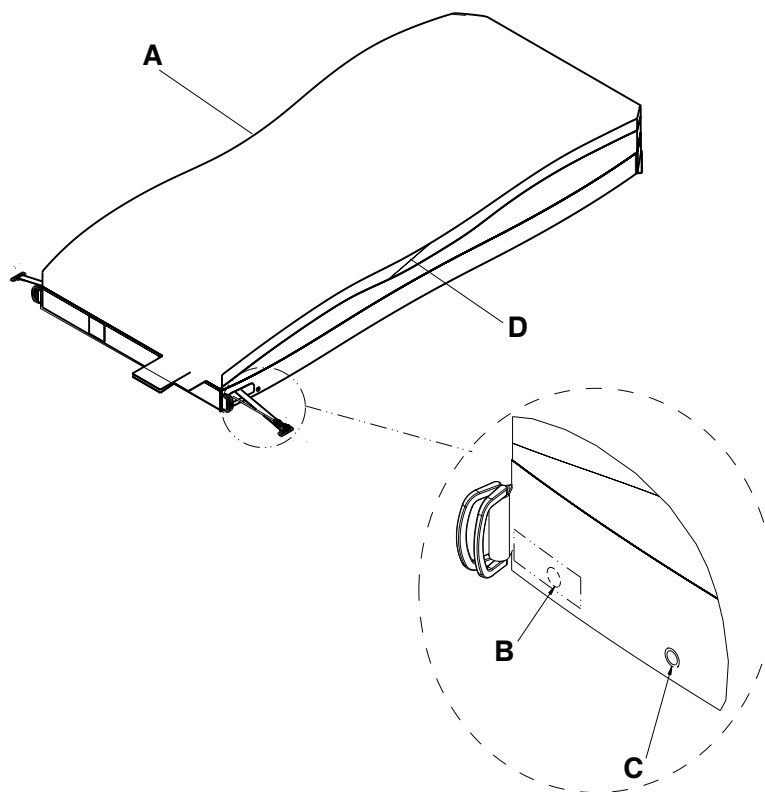
**Figure 18 – Top cover**

**Note** - The zipper starts on the patient right side near the foot end.

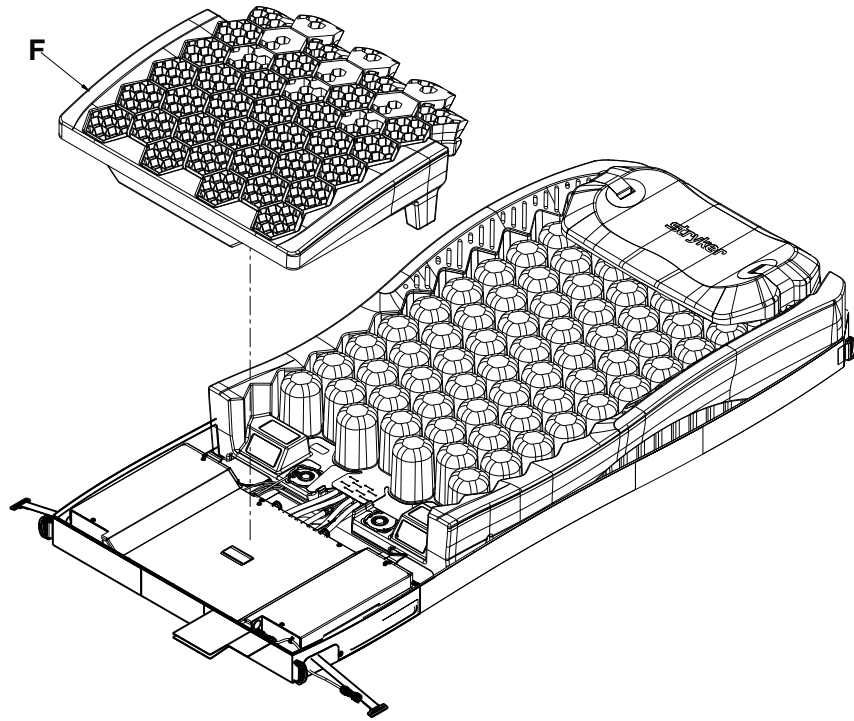
**Figure 19 – Gel crib**

9. Fold the cover up toward the head end.
10. Separate the six **Velcro®** connectors that hold the foot section gel crib to the pod assembly.
11. Lift upward and remove the foot section gel crib (F) (Figure 19). Save the gel crib.

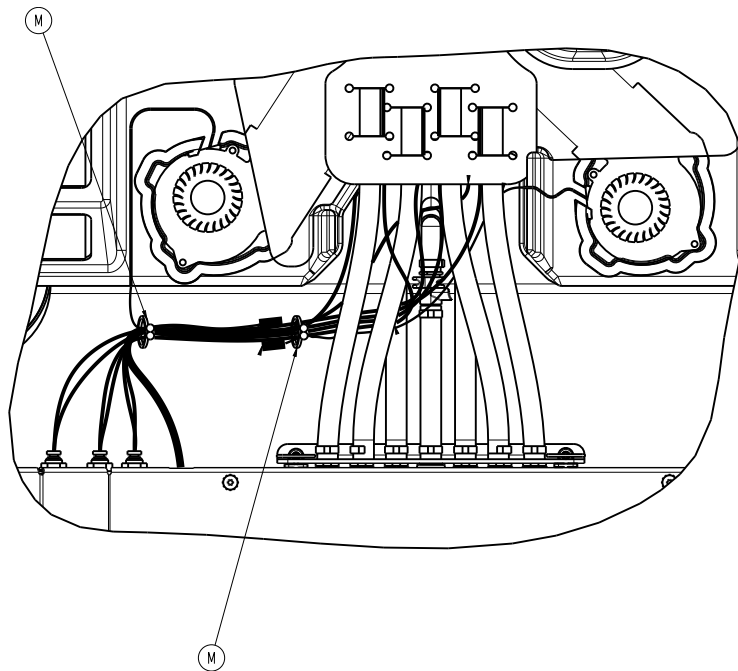
**Figure 20 – Purse lock wire tie**

12. Remove the two purse lock wire tie (M) (Figure 20). Save the purse lock wire ties.

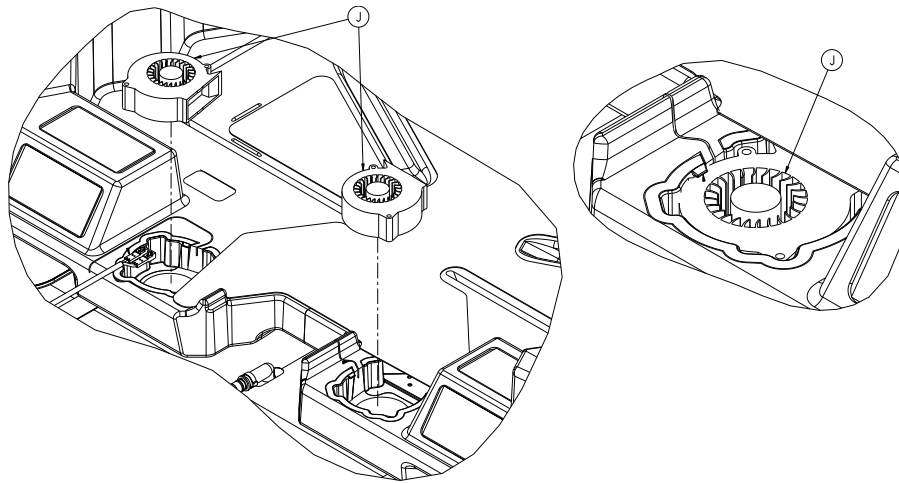
**Figure 21 – LAL fan**

13. Disconnect the LAL fan from the quick connection.

14. Remove the LAL fan from the LAL fan nest . Discard the LAL fan (J) (Figure 21).

**Note** - During reinstall, route the cable back through the foam. Make sure that the new fan is seated into the LAL fan nest.

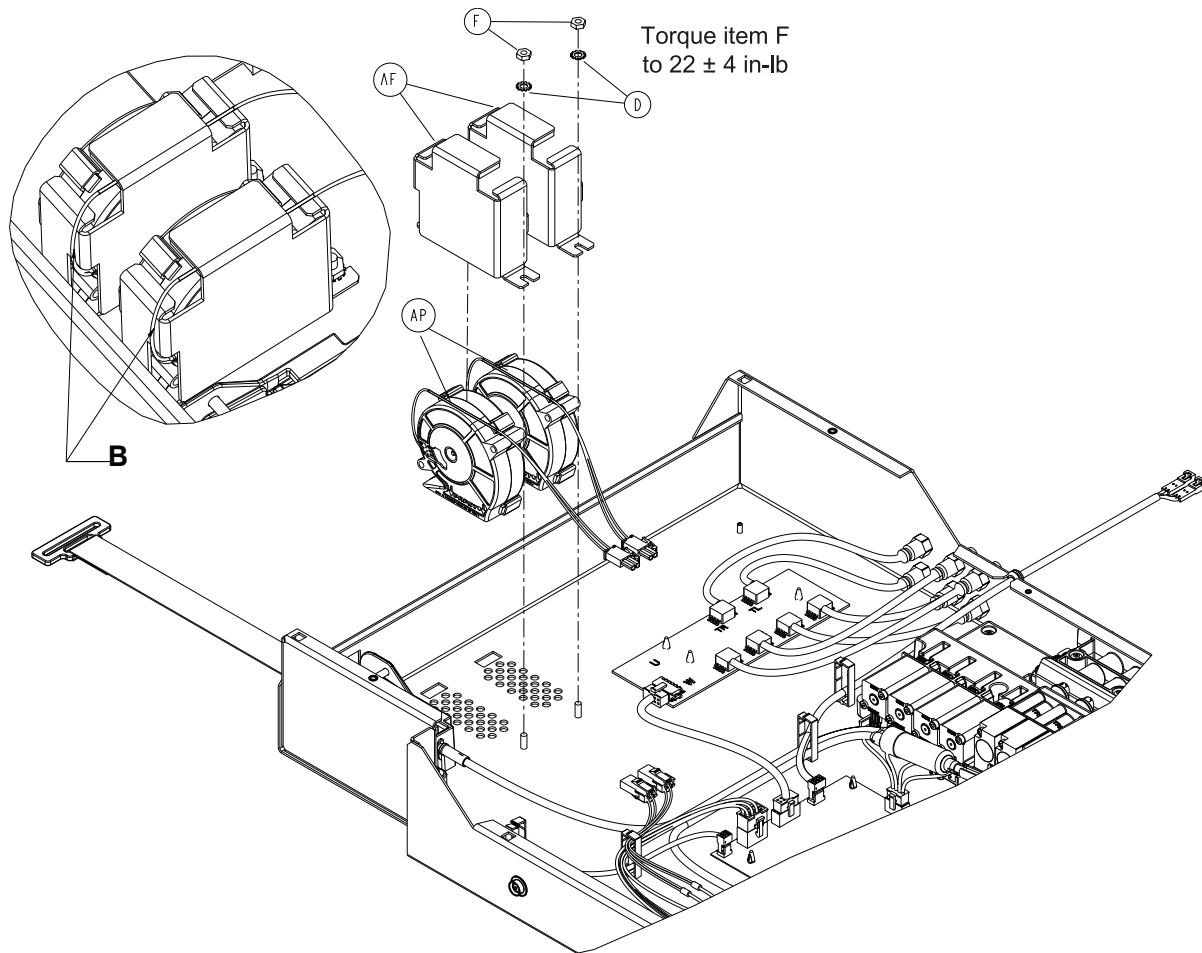
**Figure 22 – Cooling fan and cage**

**Note** - During reinstall, torque the nut (F) to 22 ± 4 in-lb.

4. Remove the cooling fan (AP) from the fan cage (AF) (Figure 22). Discard the cooling fan.

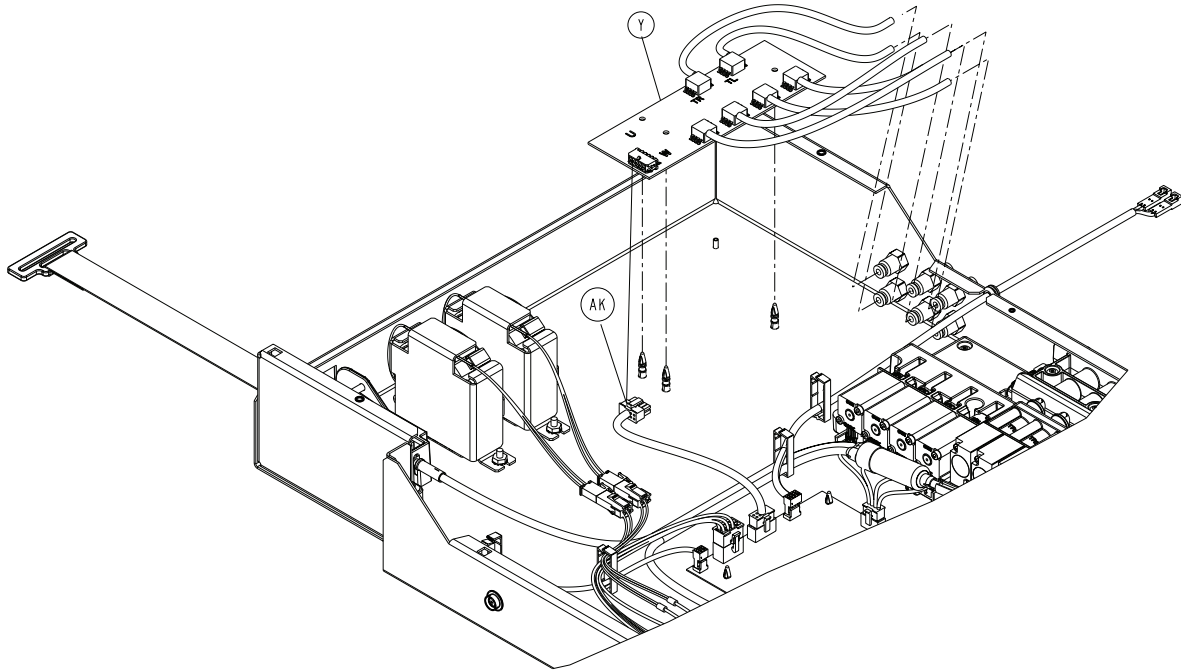
**Figure 23 – Sensor board**

**Note** - During reinstall, align the standoffs to the main board and press near the standoffs to seat the main board. Do not bend the board.

6. Remove and discard the sensor board.
7. Reverse steps to reinstall.

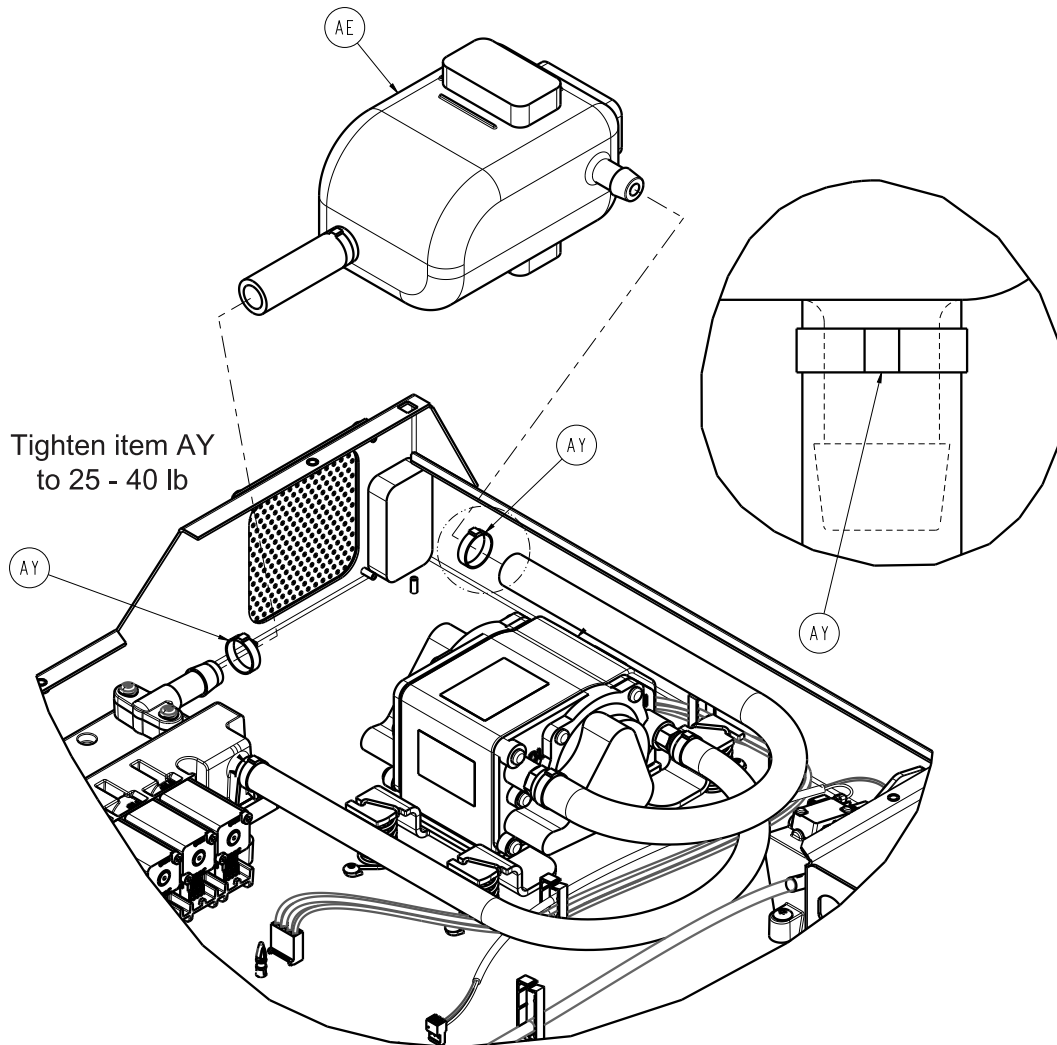
Figure 24 – Resonator

- During installation, before you cut the end off of the cable tie, use the diagonal pliers to pry the slack out of the cable tie (one to two clicks).
- During installation, tighten the cable tie (AY) to 25 - 40 lb.

3. Pull to disconnect each of the hoses from the resonator (AE) and the manifold (Figure 24).
4. Remove and discard the resonator.
5. Reverse steps to reinstall.
