## Isolibrium® PE support surface

### Maintenance Manual

REF 297300000000

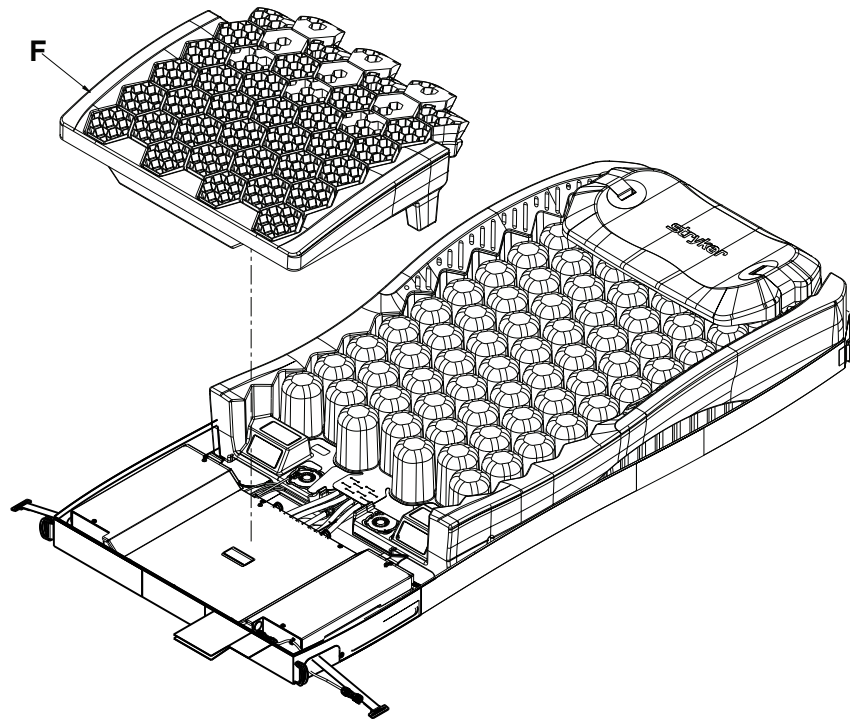
Figure 25 – Gel crib

1. Remove the top cover. See *Cover replacement, top* (page 22) .
2. Separate the six **Velcro®** connectors that hold the foot section gel crib to the pod assembly.
3. Remove the foot section gel crib (F) (Figure 25). Save the gel crib.

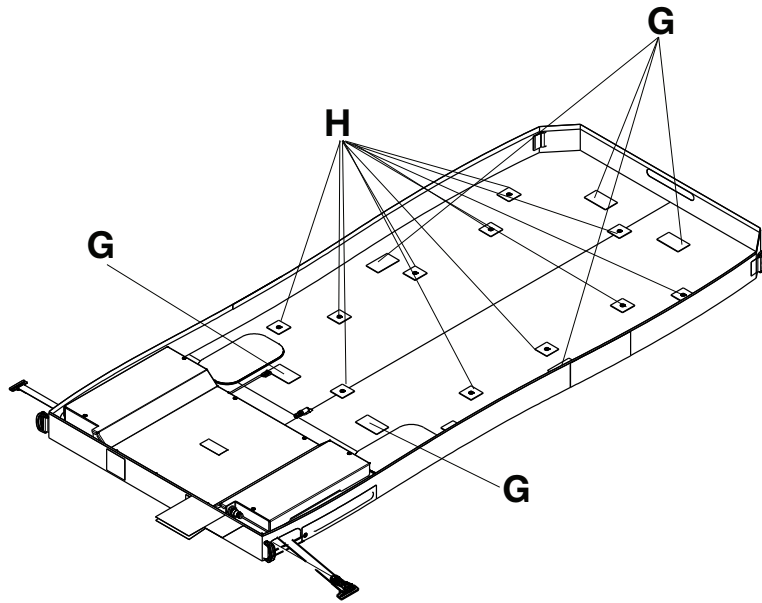
Figure 26 – Pod Velcro® and snap retainers

6. Remove the hoses from the purse clips.
7. Lift up on the foam crib, reach between the foam crib and the bottom cover to unhook the six **Velcro®** retainers (G) and unsnap the 12 snap retainers (H) (Figure 26).

8. Remove and discard the turn bladder assembly.
9. Reverse steps to reinstall.
